# **Dixon Engineering, Inc.**

Preliminary Maintenance Inspection  
1,500,000 Gallon Hydropillar  
(Boyd Orchard)

Martinsburg, West Virginia

Inspection Performed: September 19, 2019  
Reviewed by Joseph T. Hoban, P.E.: February 24, 2020

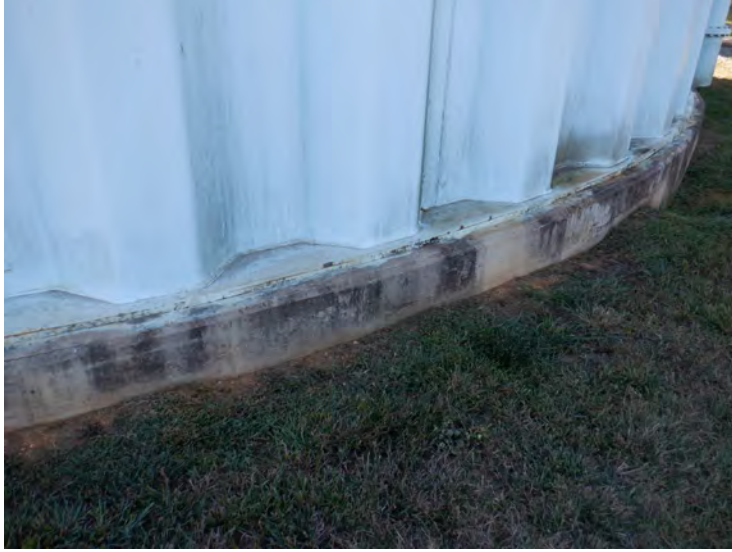
1) The foundation is in good condition.

Coat the exposed concrete with an epoxy coating system to help prevent deterioration. The cost would be incidental to exterior painting.

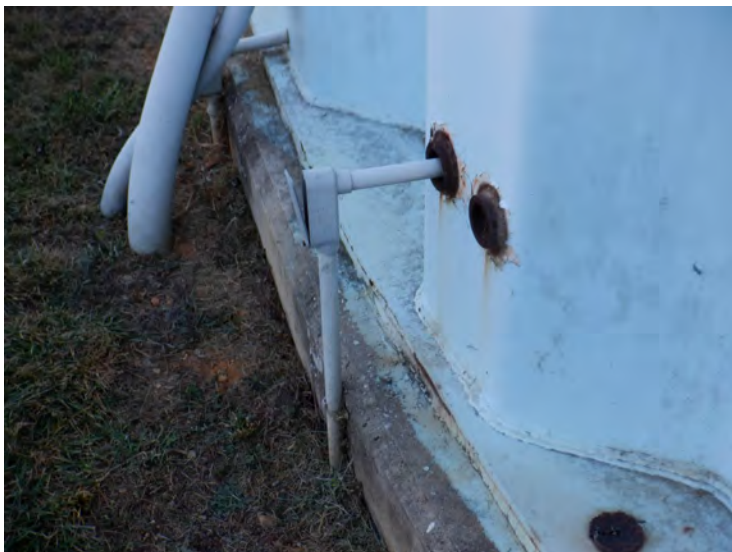
3) The electrical conduit penetrations in the column are not fully sealed.

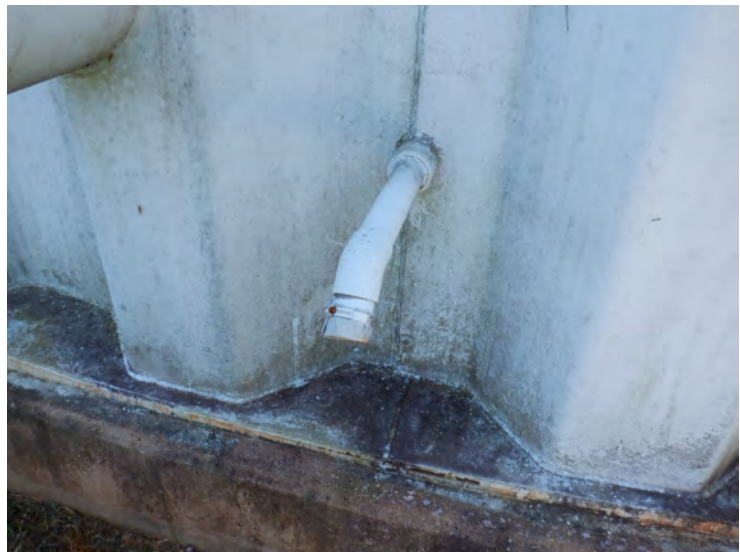
4) The overflow pipe elbows downward and routes directly underground.

Modify the overflow pipe to create an air gap in the overflow pipe by removing the underground section at the bolted flange. Install a screened flap gate on the new discharge end and a concrete catch basin to route water away from the foundation. The estimated cost is \$8,000.

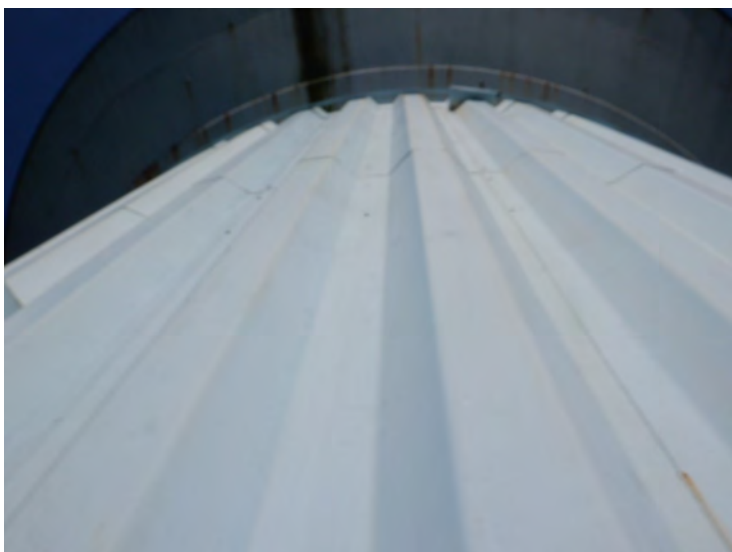
9) The coating on the column has faded significantly.

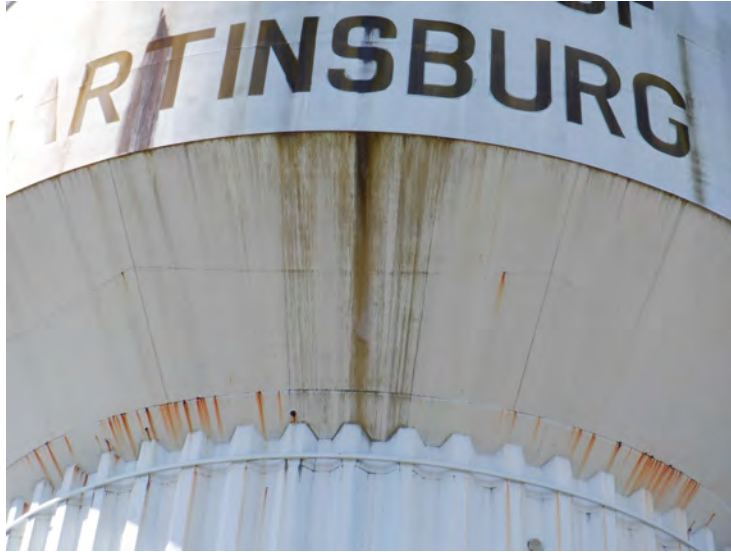
10) There are numerous coating failures to the substrate on the bowl.

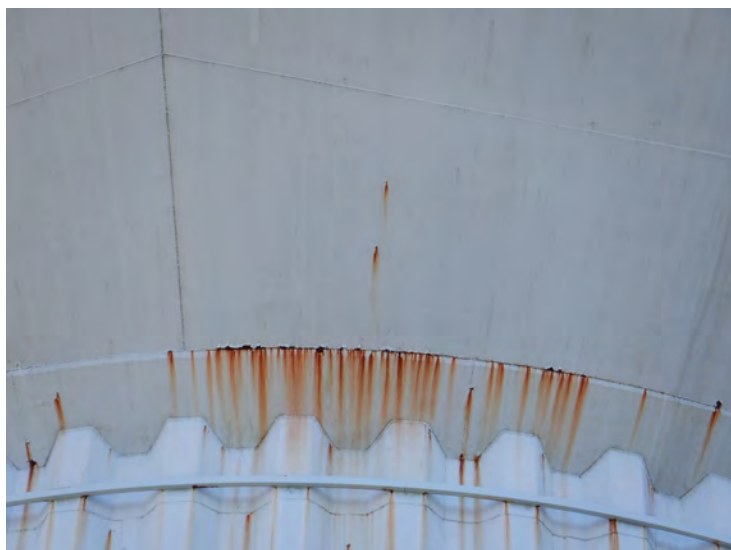
12) Coating failures are on both the weld seams and randomly throughout the flat panels.

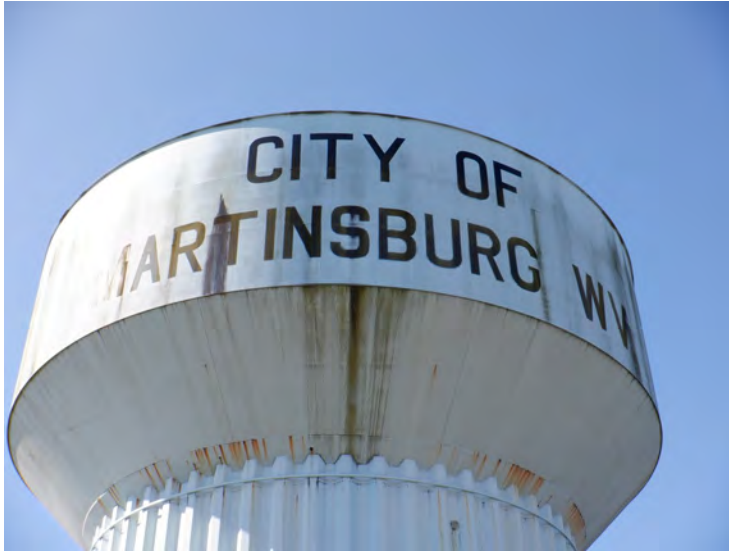
13) There is mildew growth on the sidewall and bowl.

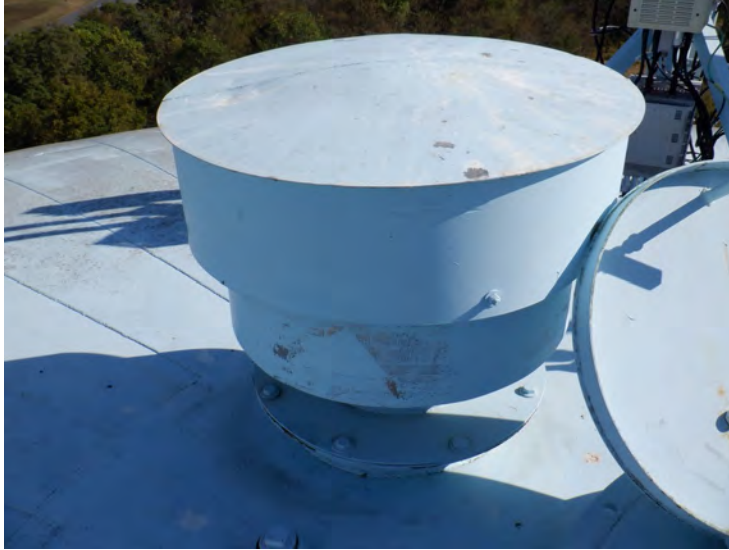
22) The roof vent coating is in fair condition.

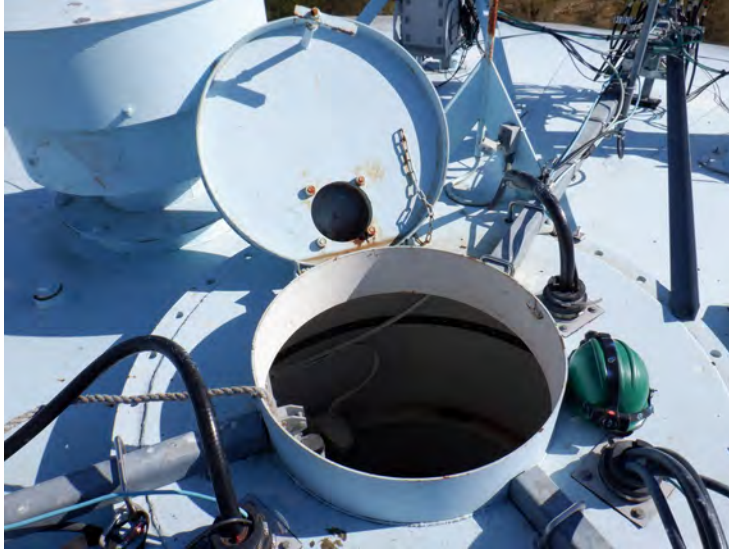
25) The access tube manway is in good condition. There is a four inch vent attached to the manway cover.

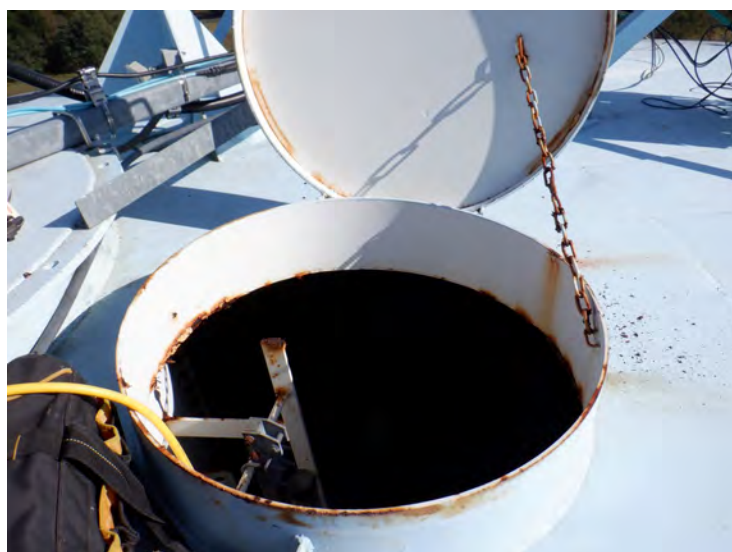
27) The wet interior roof hatch coating is in poor condition.

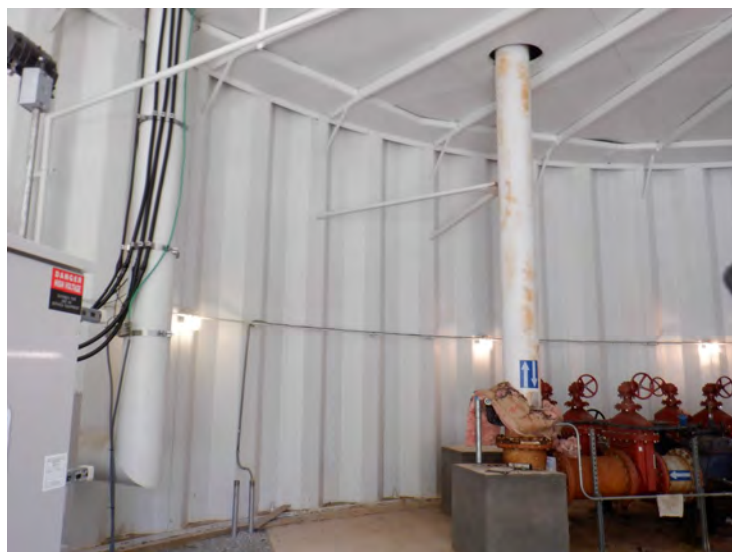
30) There is rust bleedthrough on the fill pipe throughout the dry interior.

Abrasive blast clean the piping to a commercial (SSPC-SP6) condition and repaint with an epoxy system. The cost would be incidental to the dry interior partial repaint.

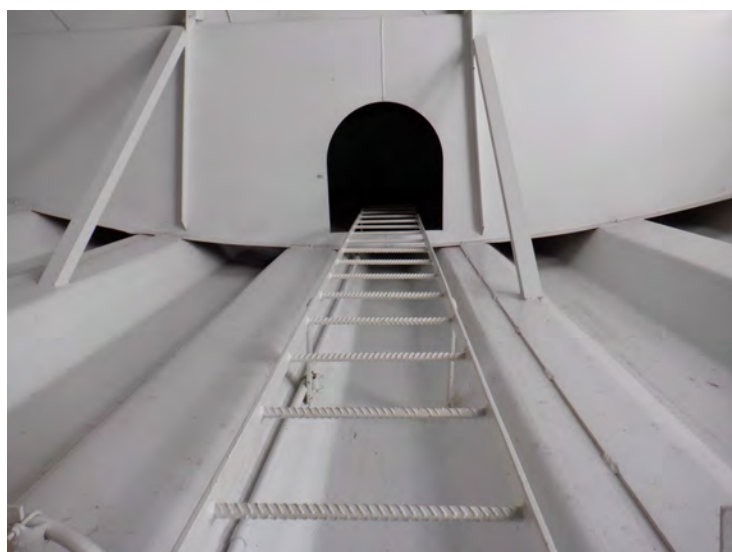
33) The column ladder is in good condition, but does not have a fall prevention device.

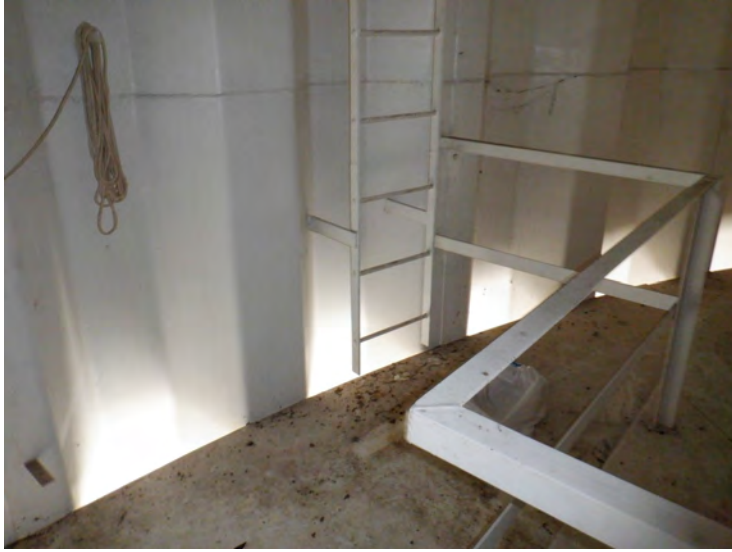
34) The ladder leading to the bird hatch does not have a fall prevention device.

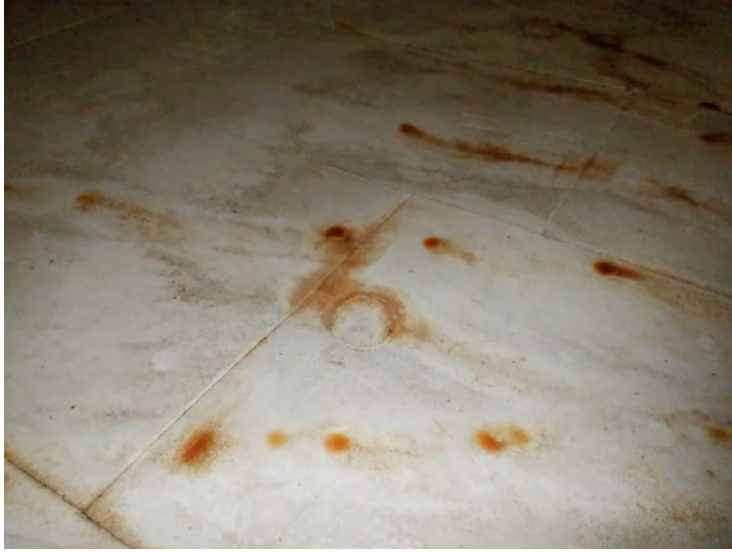
37) Spot coating failures to the substrate on the condensate platform.

Spot abrasive blast clean the dry interior to a commercial (SSPC-SP6) condition including the topside of the platform, the entire access tube, the entire bowl, the entire baseplate, and other areas of failed coating. The prepared surfaces would be coated with an epoxy system. The estimated cost is \$30,000.

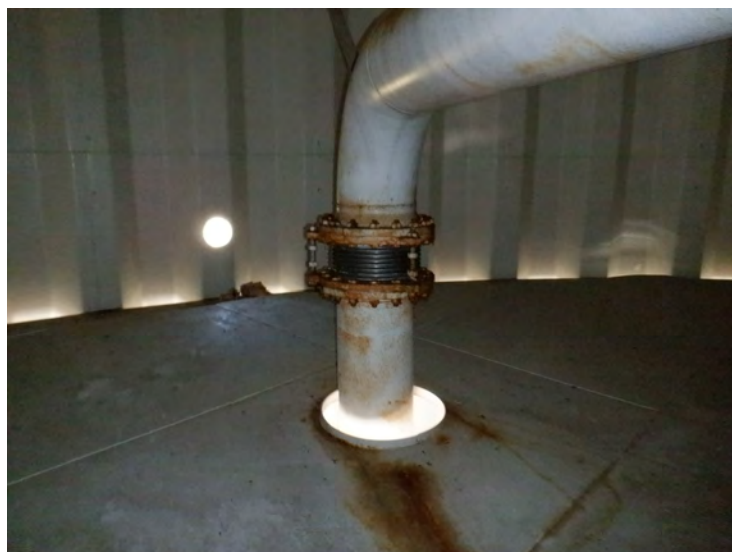
39) The expansion joint on the fill pipe is in good condition. There are spot coating failures on the flanges and hardware.

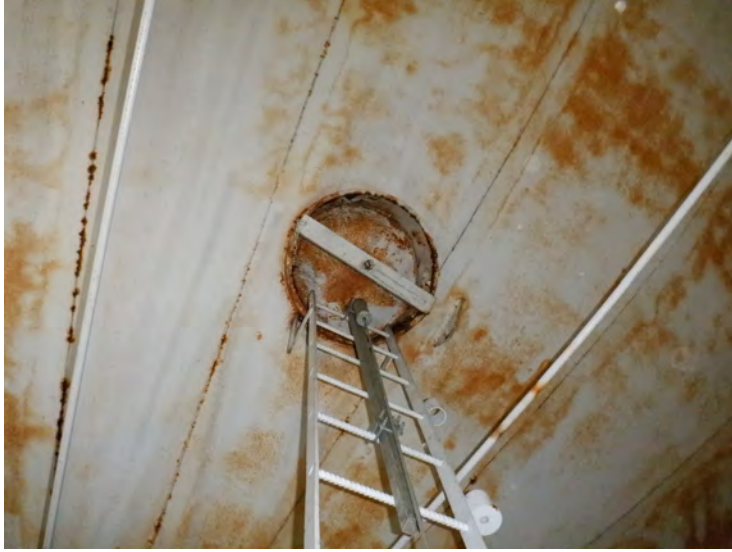
40) The bowl manway coating is in poor condition.

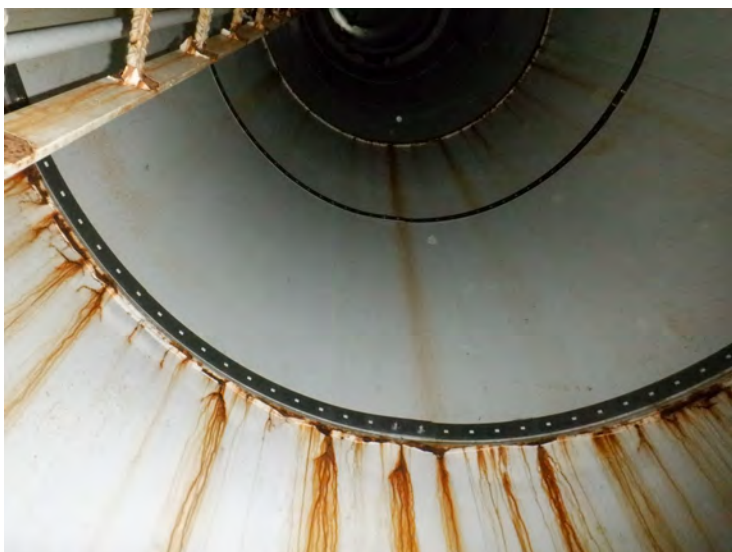
45) There are spot coating failures behind an expansion bracket inside the access tube.

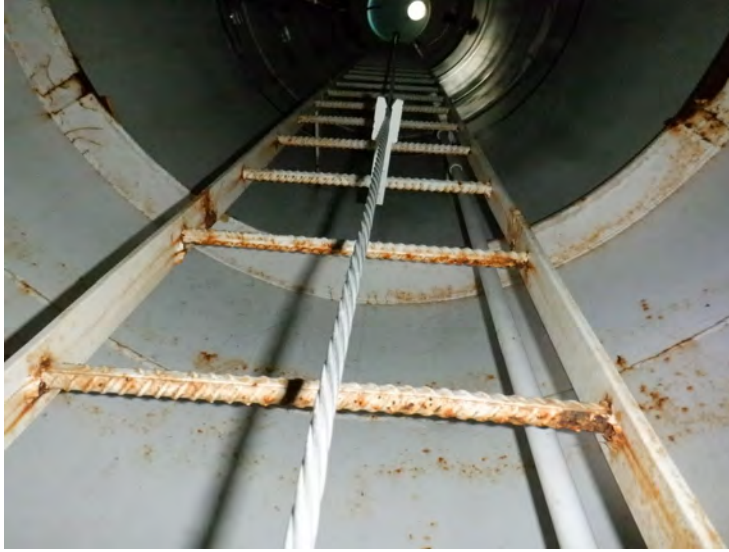
46) Spot coating failures to the substrate on the access tube ladder.

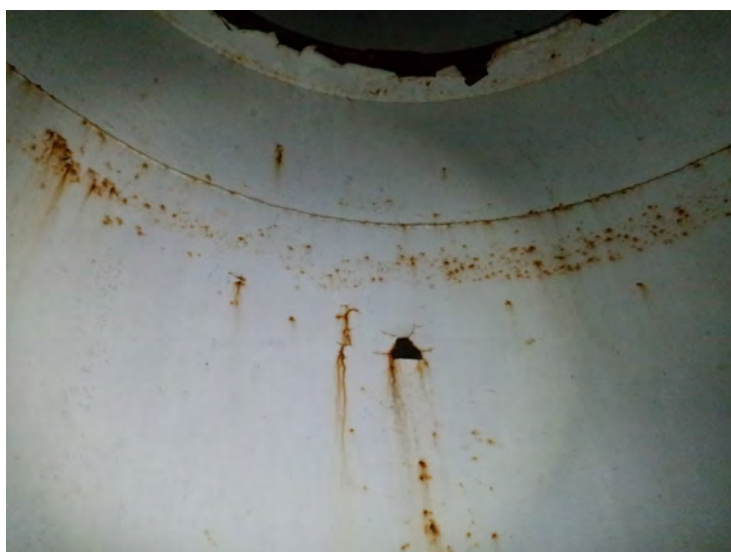
48) There are numerous spot coating failures to the substrate inside the access tube.

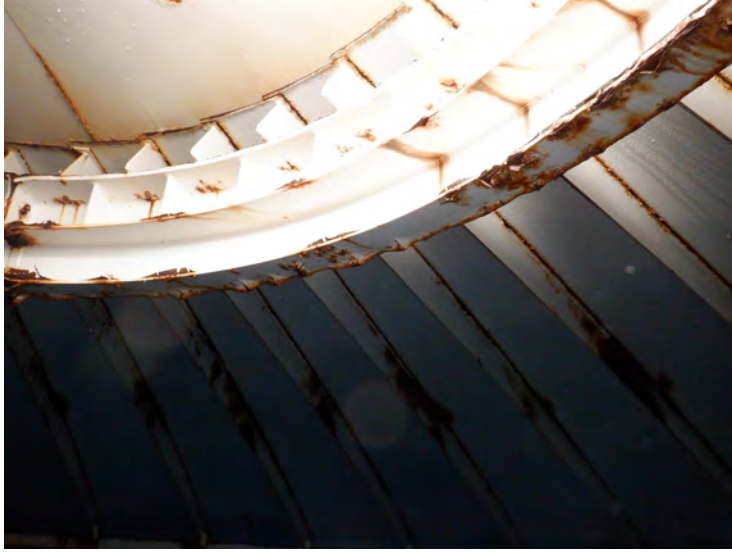
49) Rust bleedthrough and spot coating failures to the substrate on the wet interior stiffeners.

Monitor the corrosion on the edge of the roof stiffeners. Repaint the roof before metal loss becomes significant.

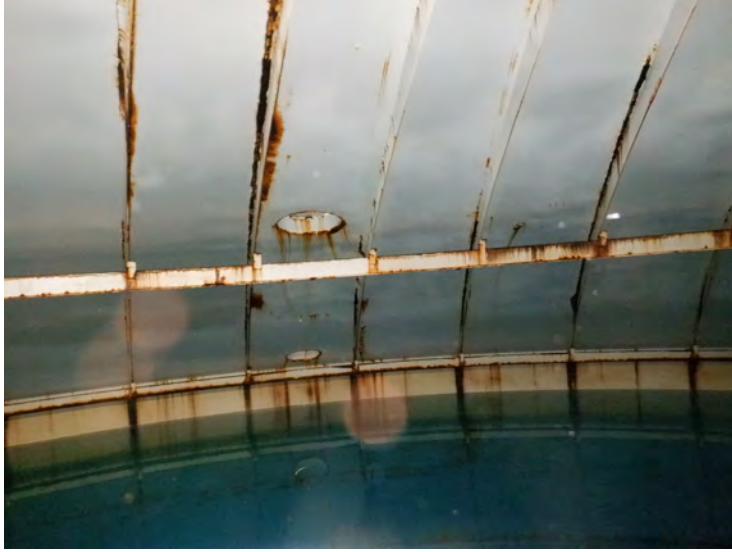
52) There are spot coating failures on the roof hatch penetrations into the wet interior.

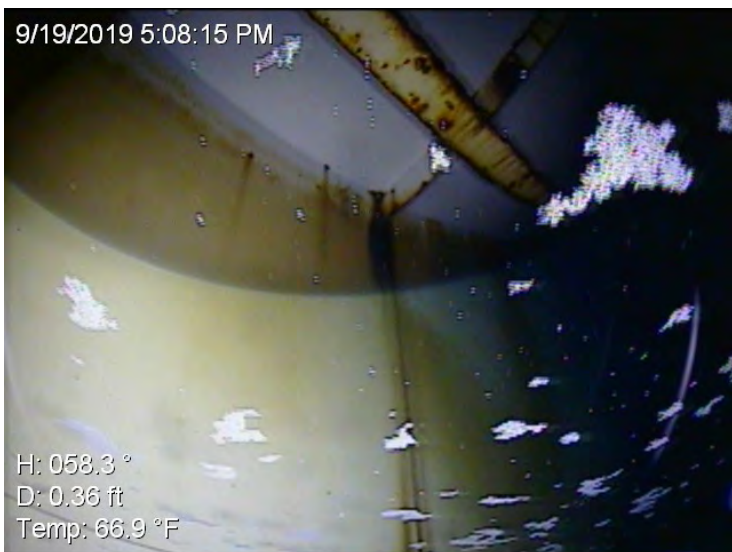
54) Edge corrosion on the roof painter's rings.

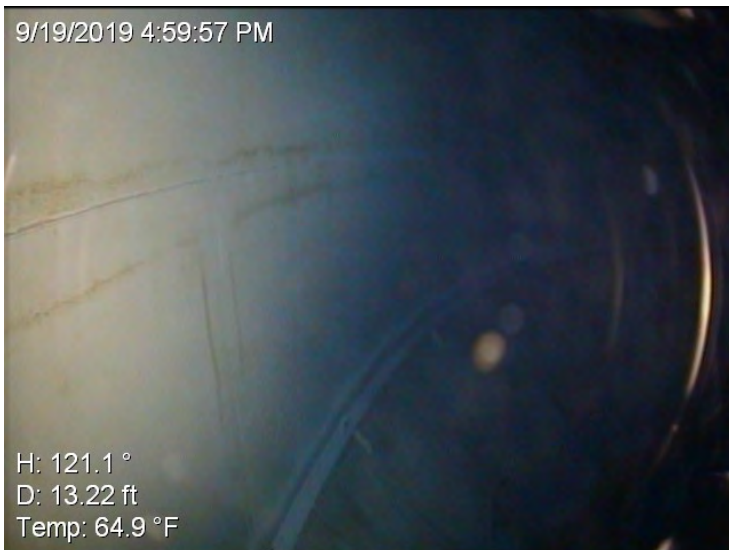
61) The sidewall coating is in fair condition.

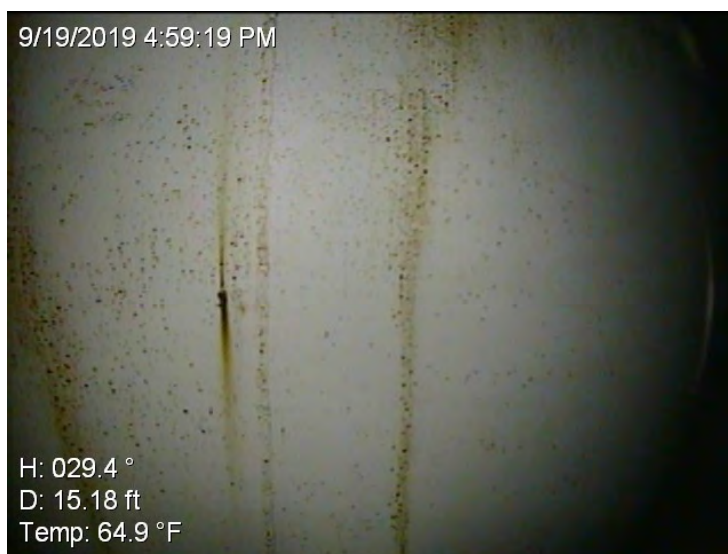
62) Pinhole coating failures on the sidewall.

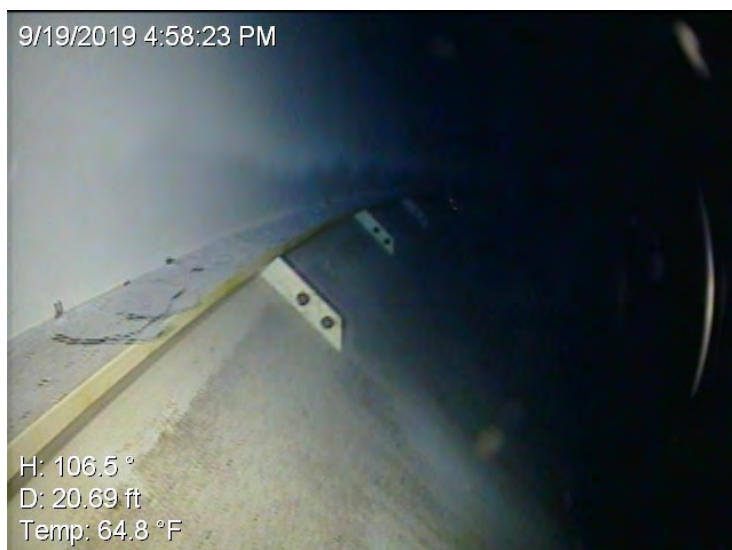
63) The stiffener at the transition is in good condition.

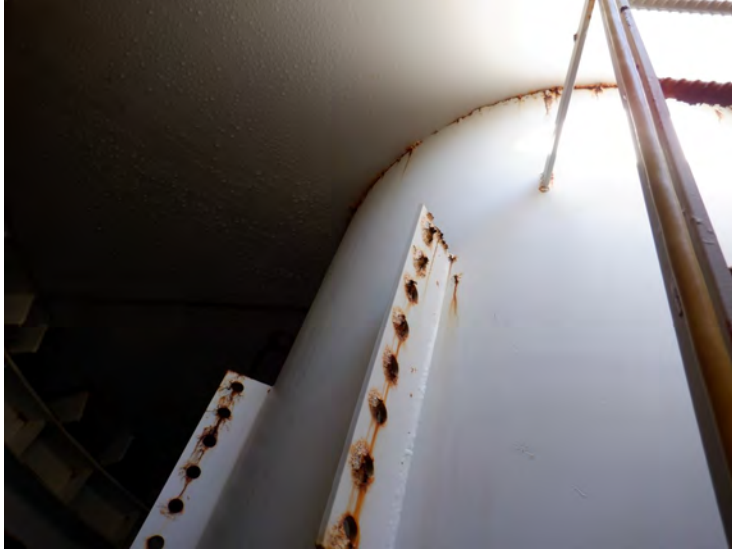
67) Spot coating failures to the substrate at the top of the access tube above high-water line.

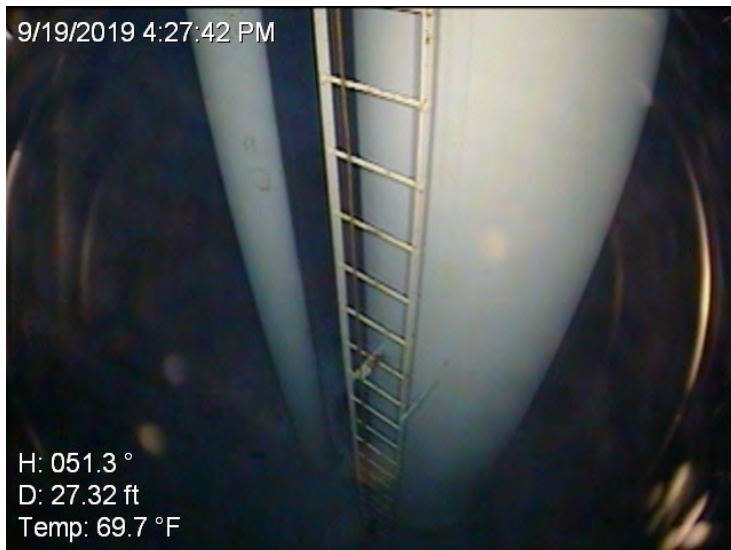
69) There are numerous spot coating failures on the overflow weir box.

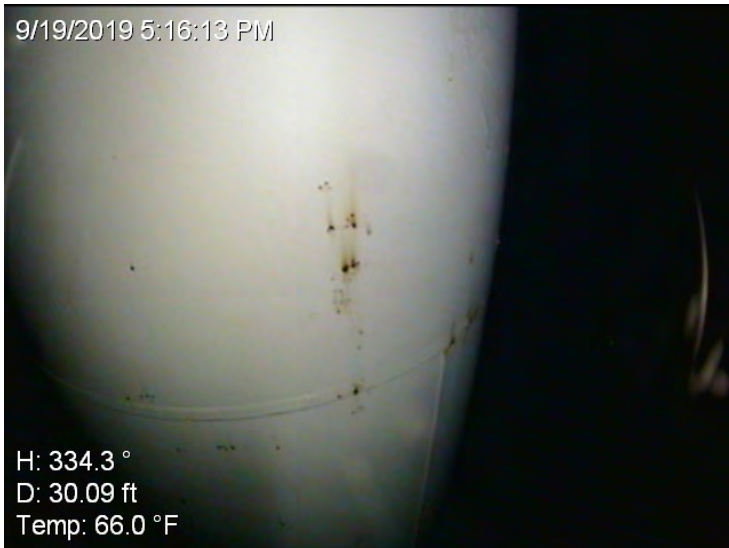
72) Spot coating failures to the substrate on an access tube stiffener.

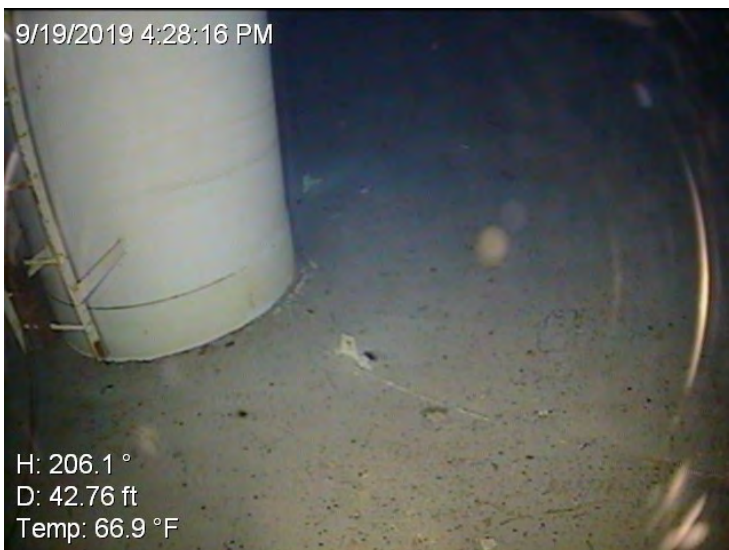
77) Spot coating failures on the fill pipe.

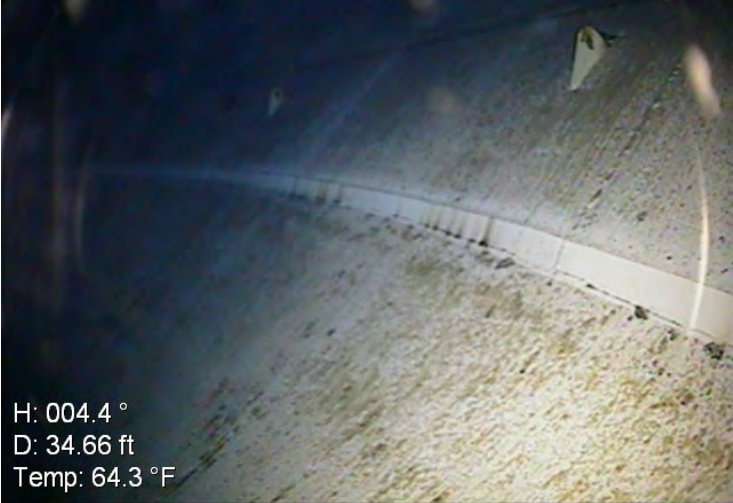
82) There are pinhole coating failures on the bowl weld seams.
