Preliminary Maintenance Inspection

200,000 Gallon Standpipe

Martinsburg, West Virginia
(Stuckey Court)

Inspection Performed: December 10, 2019
Reviewed by Joseph T. Hoban, P.E.: February 7, 2020

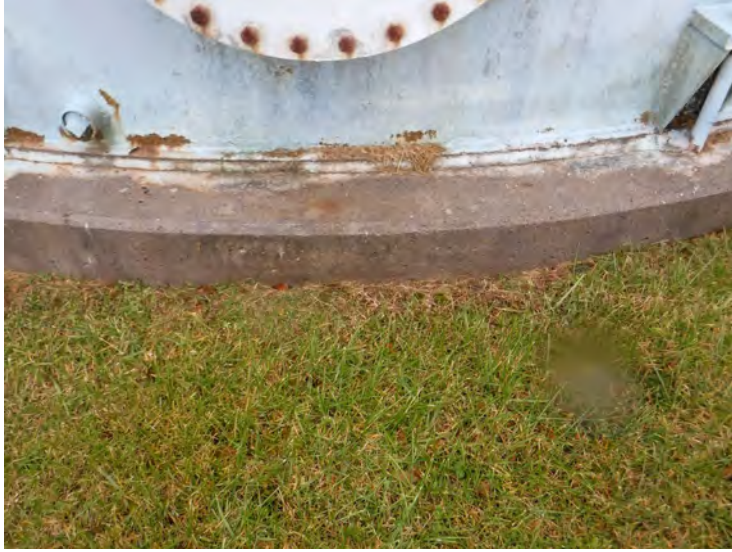
1) The foundation is in good condition.

Coat the exposed concrete with an epoxy coating system to help prevent deterioration. The cost would be incidental to exterior painting.

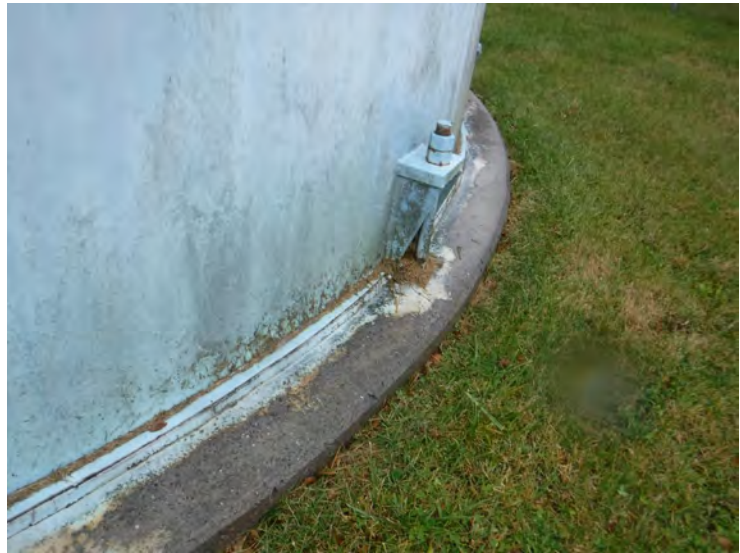
2) Same.

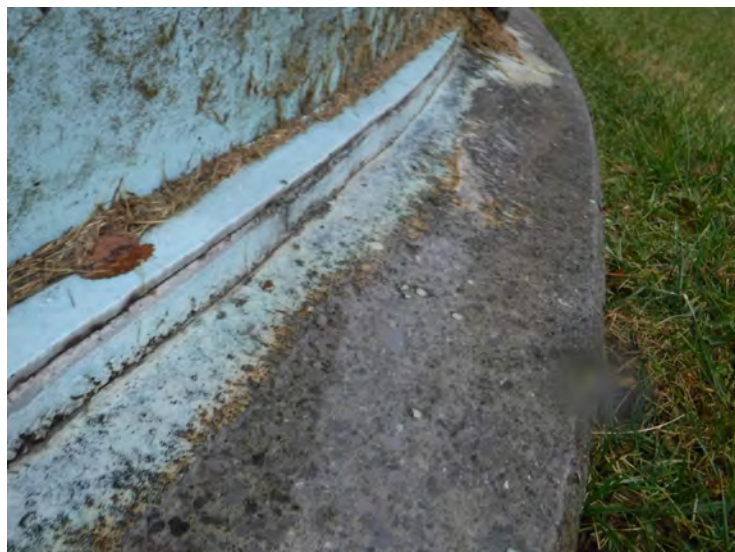
3) The grout is in good condition.

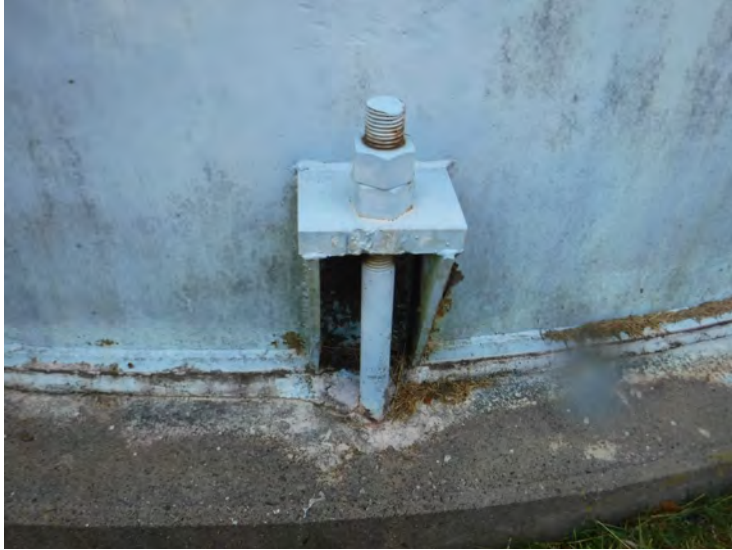
4) Typical anchor bolt is in good condition.

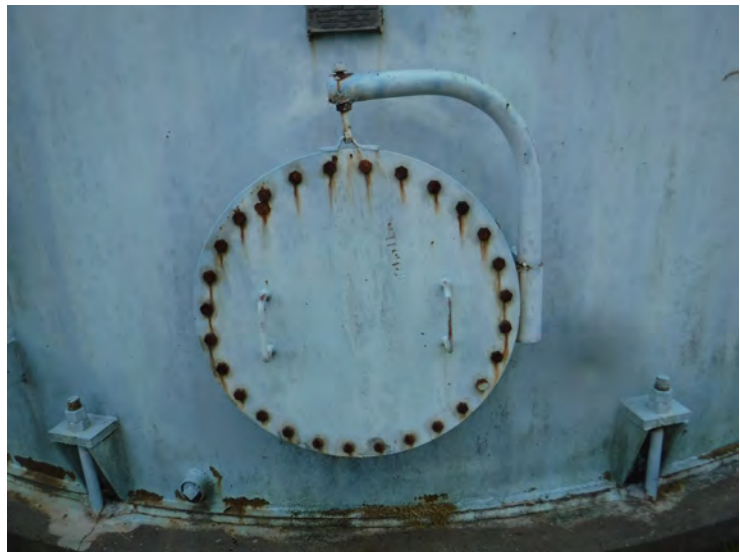
5) The sidewall manway is in good condition with minor corrosion on the bolts.

Install a 30 inch manway in the sidewall. Average rescue baskets will not pass through the existing manway. The estimated cost is \$9,000.

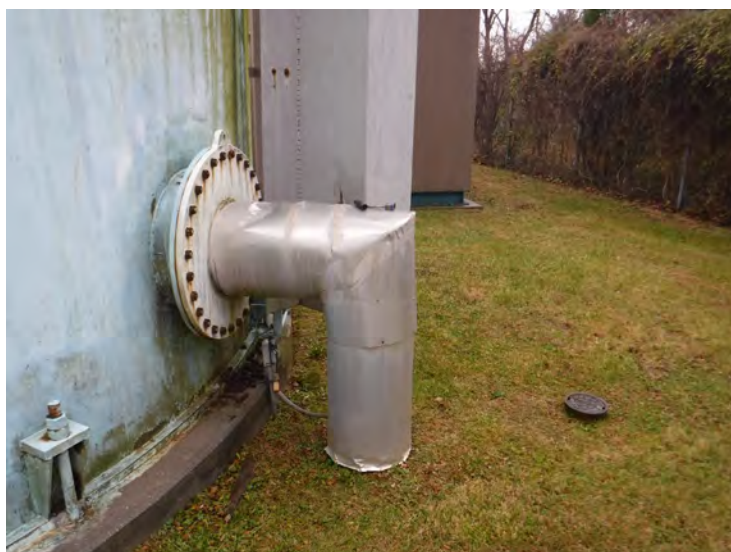
6) The fill pipe penetrates through the second sidewall manway.

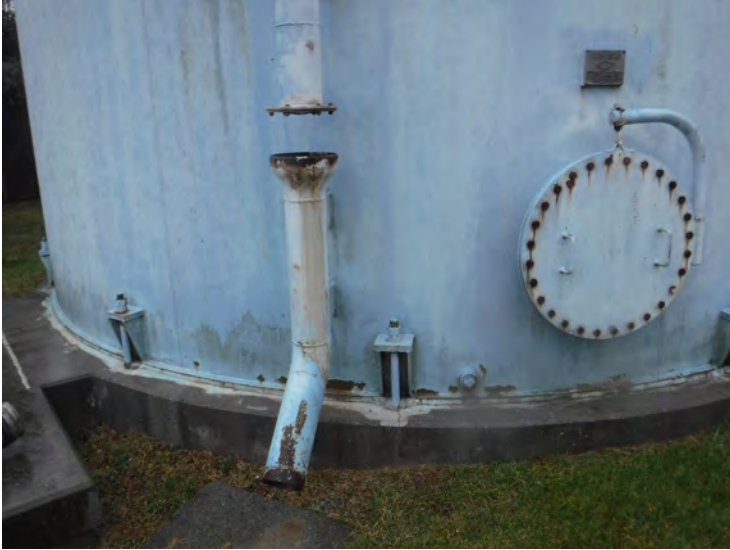
7) The overflow pipe discharge is in good condition.

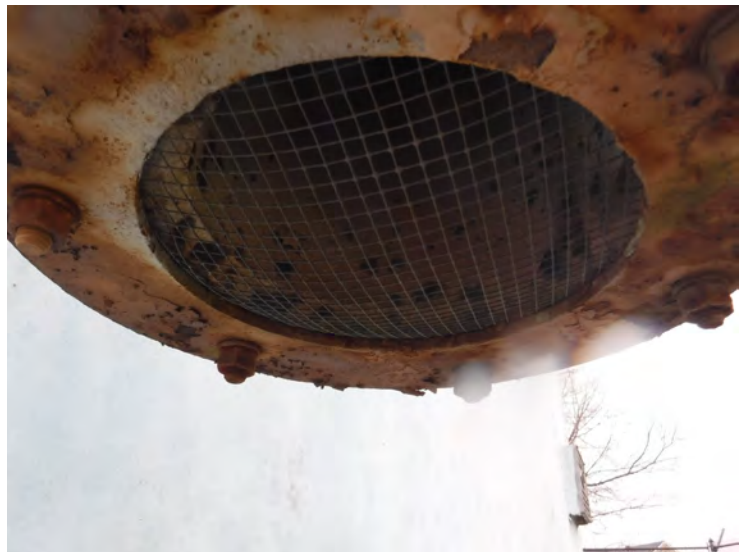
8) The overflow screen is intact but is oversized.

Replace the screen on the end of the overflow pipe with a 24 inch mesh screen. The work can be performed by in-house personnel.

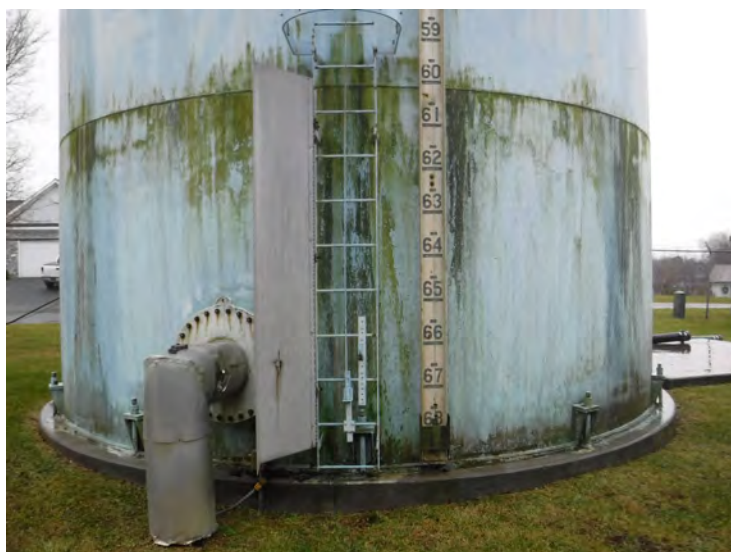
9) The vandal guard and level indicator are in good condition.

Remove the level indicator and seal the opening in the roof. The estimated cost is \$1,000.

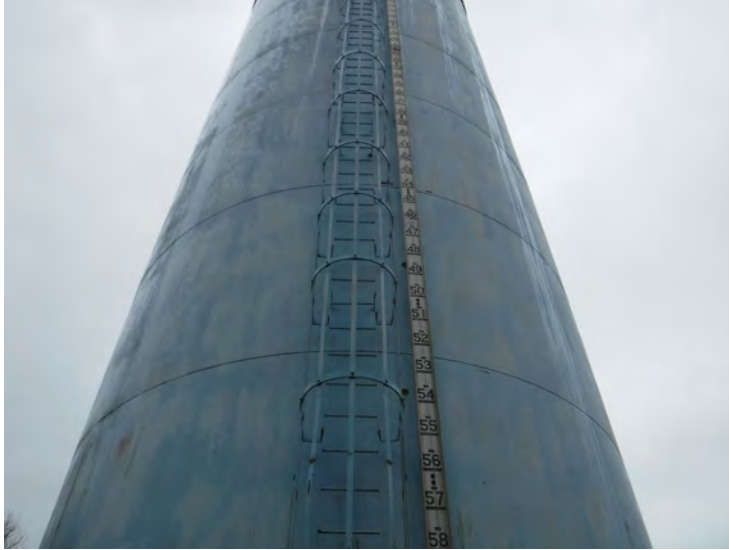
10) The sidewall ladder is in good condition.

Install a step-off platform at the top of the ladder. The estimated cost is \$6,000.

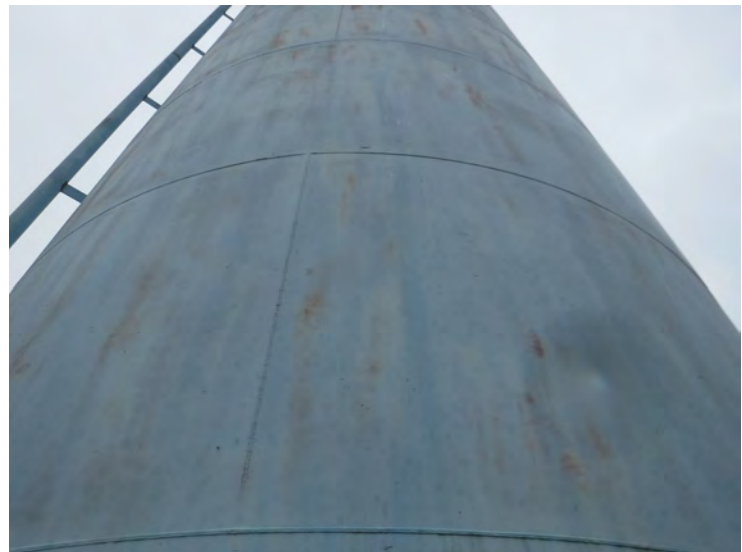
The sidewall coating is in poor condition with numerous spot failures on the lower panels and there is primer bleedthrough throughout.

11) The sidewall coating is faded and there is erosion and rust bleedthrough throughout.

Remove the existing coating by dry abrasive blast cleaning the steel to a commercial (SSPC-SP6) condition and apply a urethane system. All blast work would be performed inside a dust tight containment system using negative air pressure.

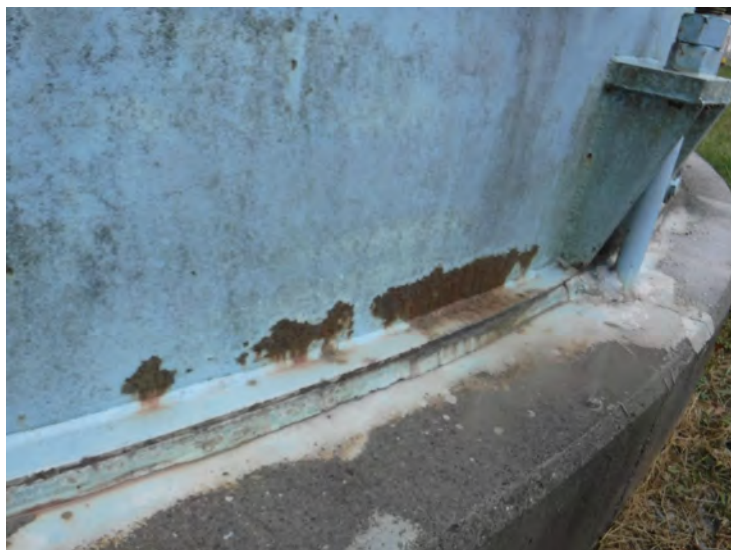
12) Spot coating failures on the lower sidewall.

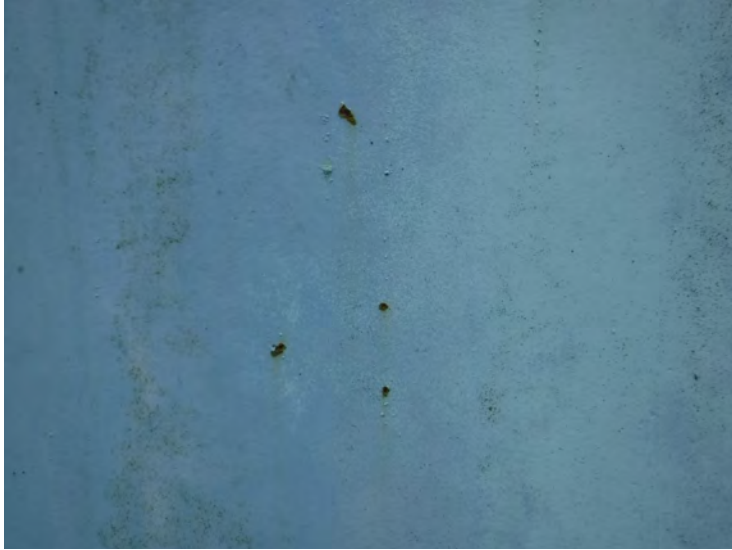
13) Same.

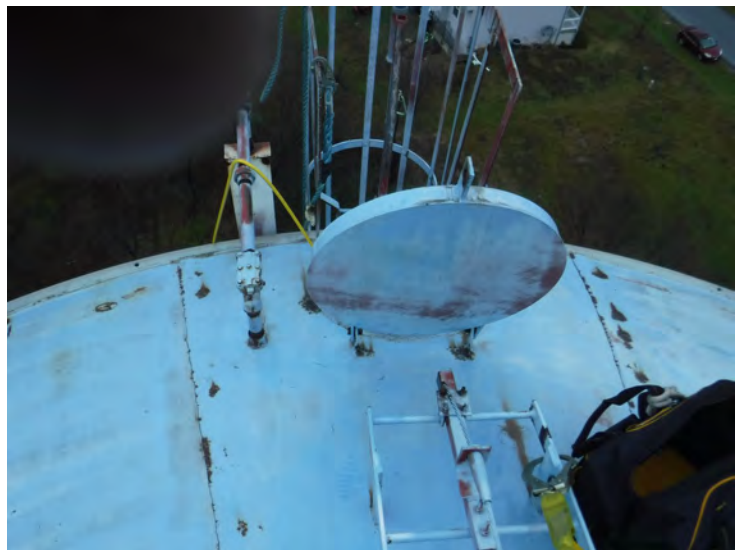
14) The primary roof hatch is in good condition.

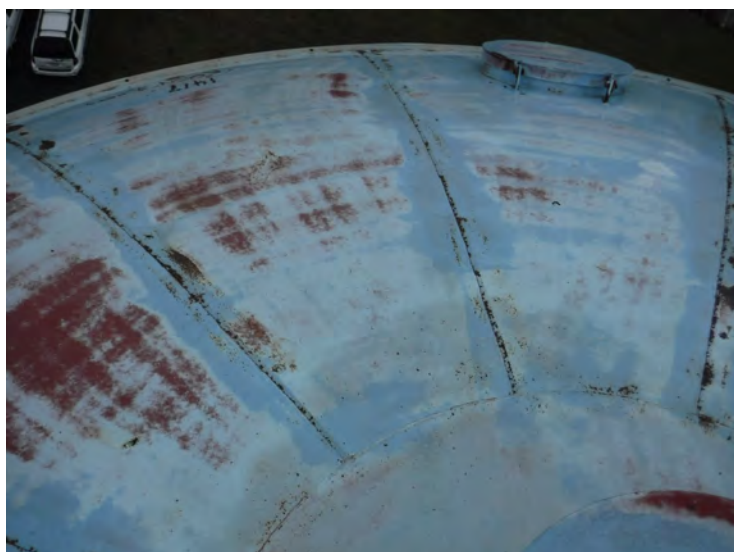
The roof coating is in poor condition with numerous spot failures, primer bleedthrough, and erosion throughout.

15) Primer bleedthrough and erosion throughout the roof. The secondary roof hatch appears to be in good condition.

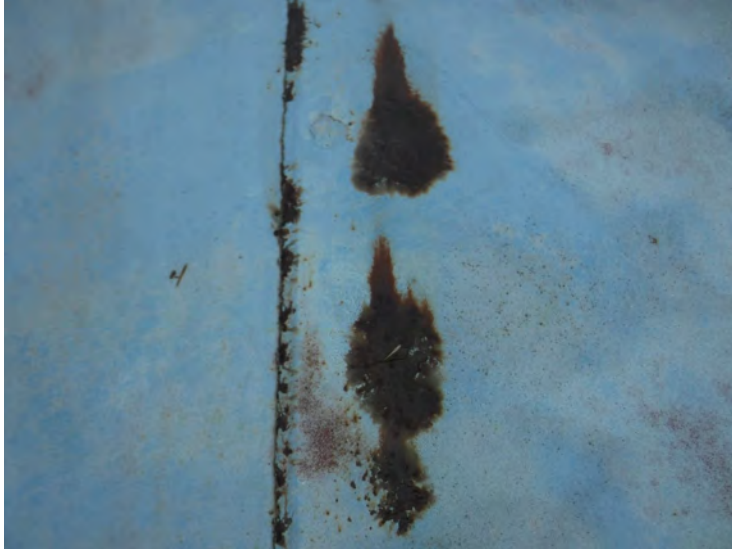
16) Spot coating failures on the roof.

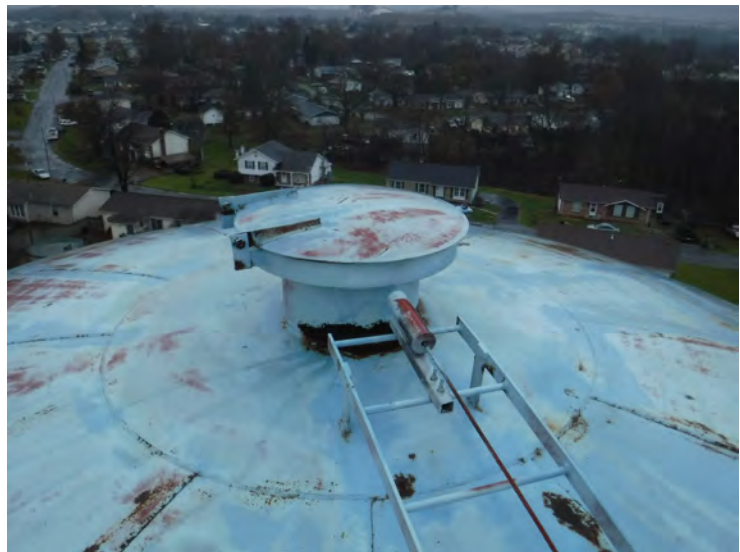
17) The roof vent is in fair condition.

Replace the roof vent with a screened frost-free pressure vacuum vent. The new vent would have a movable plate that would allow air to flow in and out of the tank even if the screens become plugged or frosted over. The estimated cost is \$6,000.

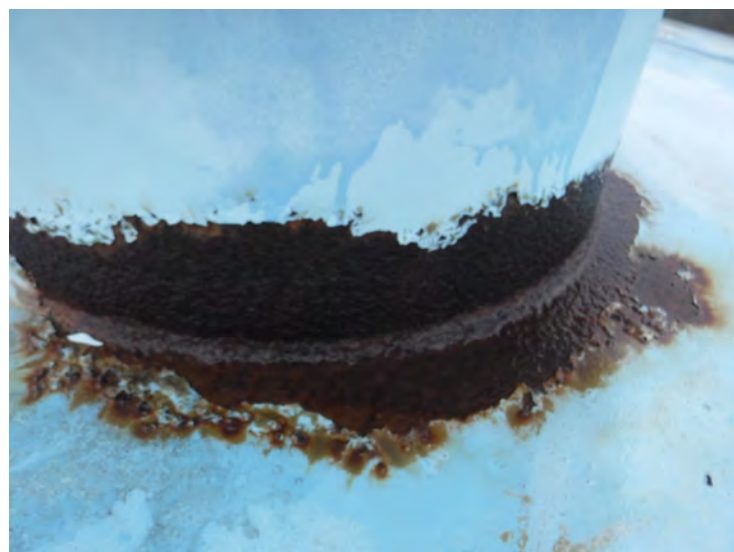
18) Coating failures on the vent neck.

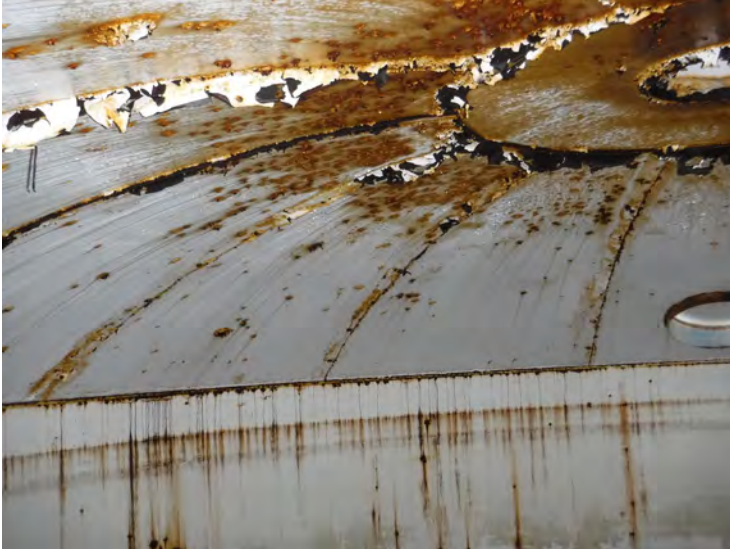
The roof coating is in poor condition with extensive failures throughout.

19) There are extensive coating failures on the wet interior roof.

Abrasive blast clean the entire wet interior to a near-white metal (SSPC-SP10) condition. Wet interior coating systems must be approved for potable water storage tanks contingent upon meeting requirements of NSF/ANSI 61.

Apply a three-coat epoxy system to the prepared surfaces. Epoxy coating systems are recommended in most applications because they have good adhesion and abrasion resistant qualities. The estimated cost is \$80,000.

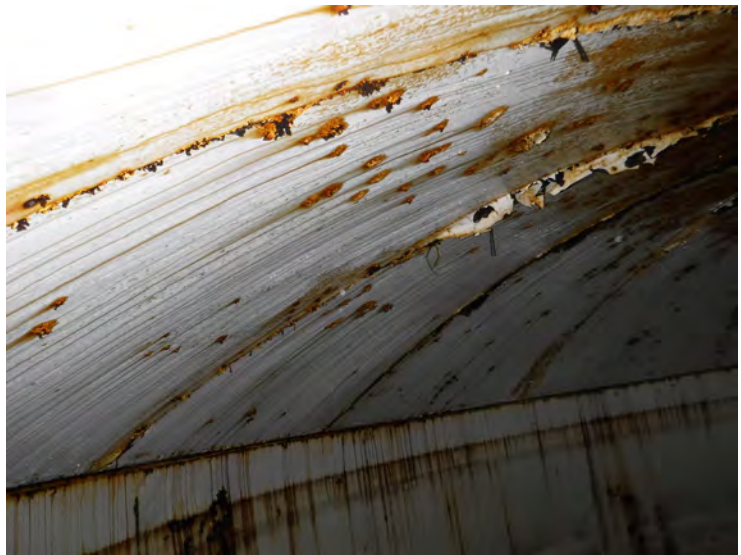
20) Same.

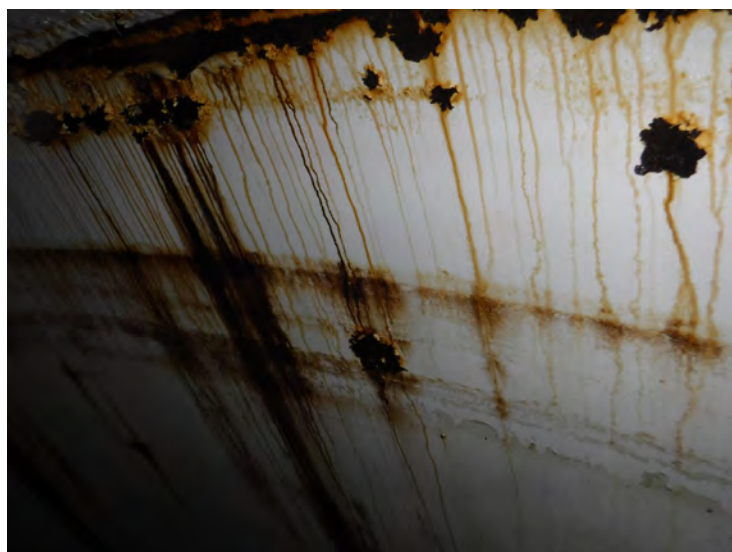
21) Coating failures on the sidewall above the high-water line.

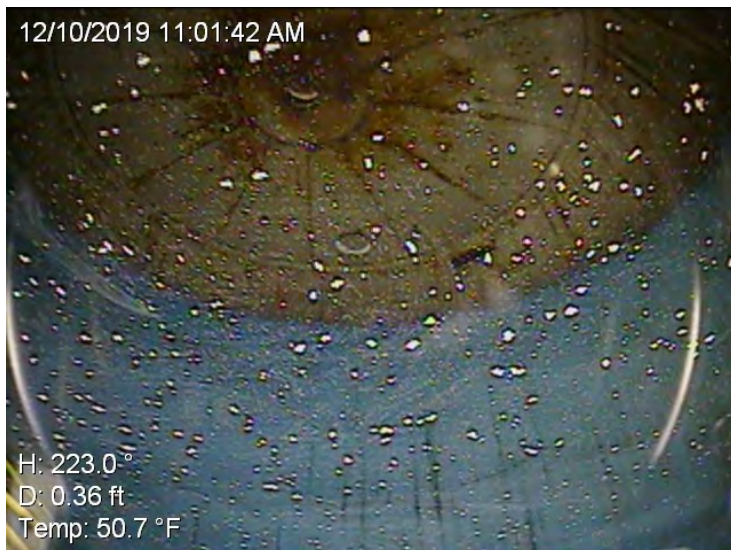
22) The roof viewed from the ROV.

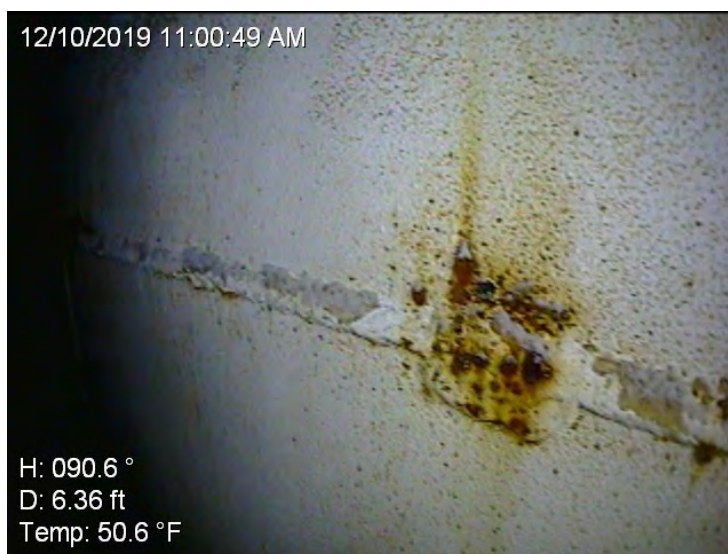
23) Spot coating failures on the sidewall weld seams.

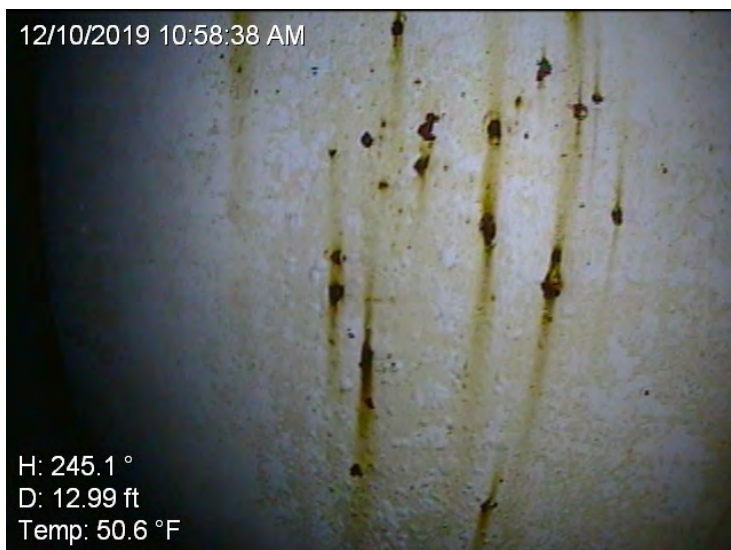
The sidewall coating is in fair to poor condition with numerous spot failures, topcoat delamination, and blisters throughout. Some of the blisters have broken open causing rust streaks. There is no significant coating damage at the high-water level which would be the area most affected by ice movement.

24) Spot coating failures on the sidewall.

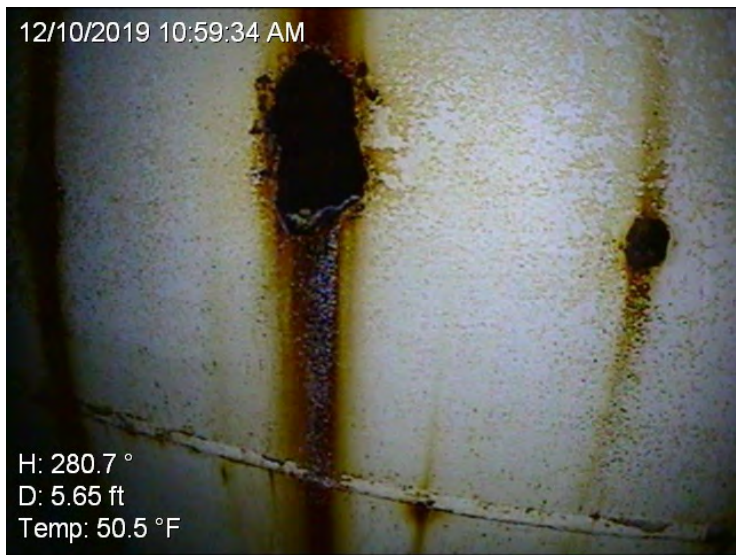
25) Same.

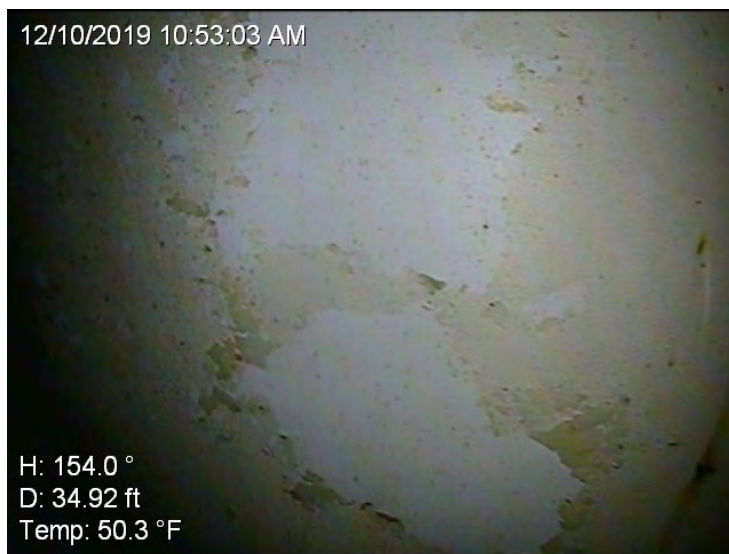
26) Topcoat delamination on the sidewall.

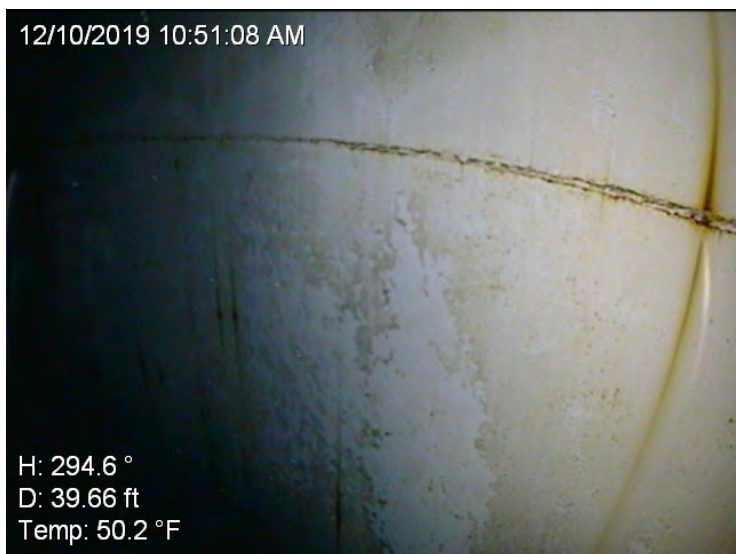
27) Same.

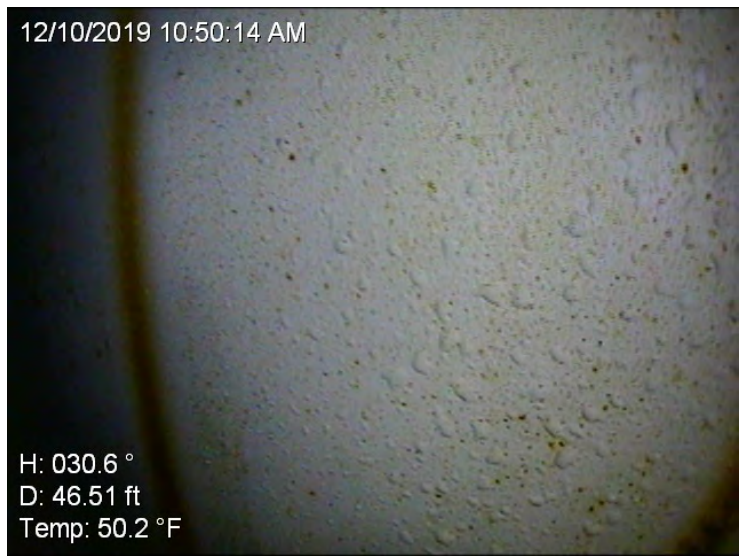
28) Coating blisters on the sidewall.

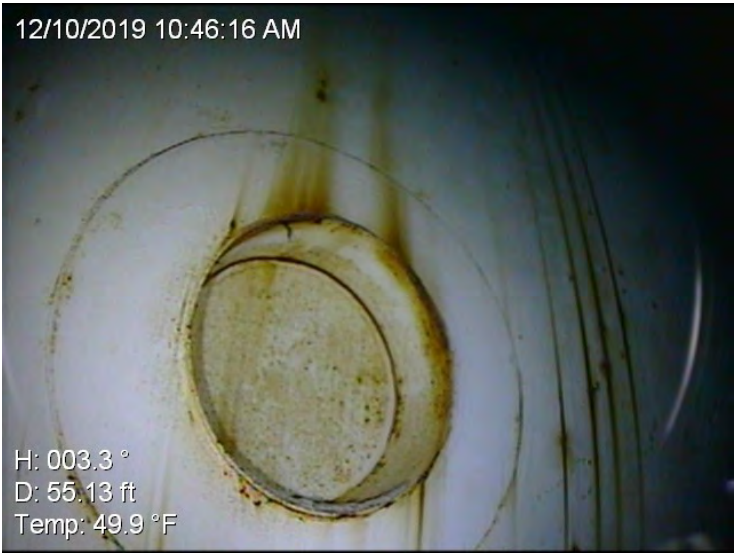
29) The manway penetration is in good condition with rust streaking.

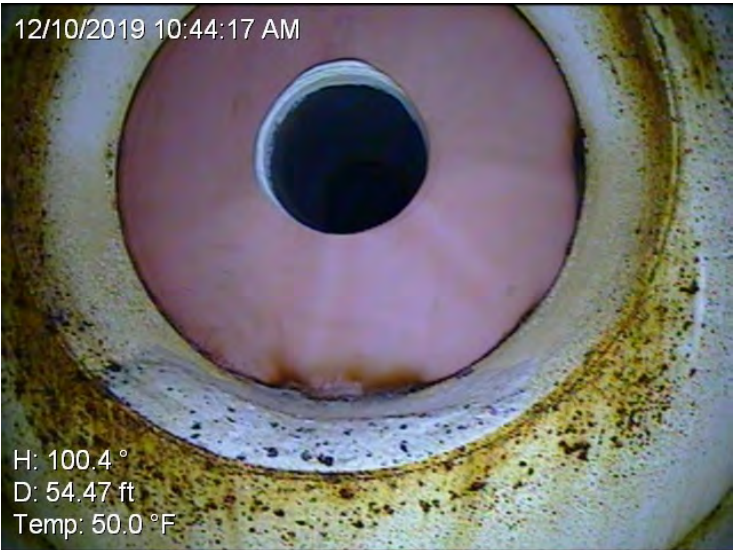
30) Spot coating failures on the second manway with fill pipe penetration.

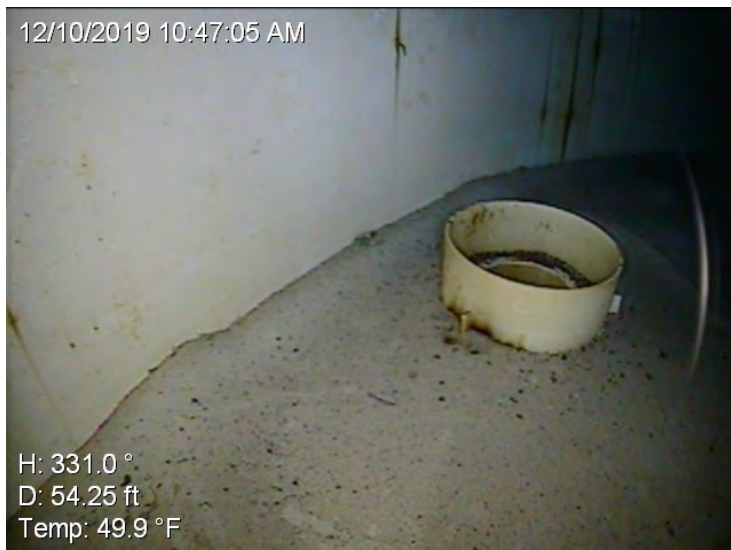
The tank draws from a separate pipe. The draw pipe penetrates through the floor and extends approximately 4 inches into the wet interior. There is no deflector plate over top of the pipe in the wet interior.

31) The draw pipe is in good condition.

Install deflector bars over the end of the draw pipe. The cost would be incidental to the next paint project.

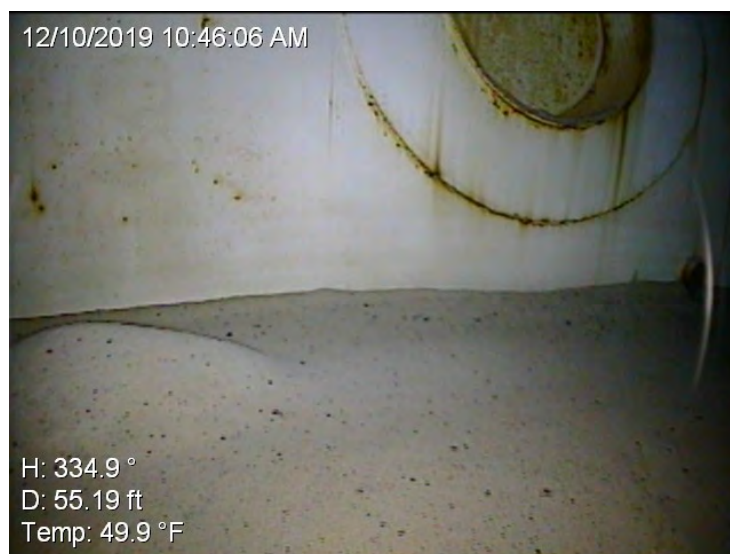
The floor was covered with approximately 2 inches of sediment that limited the amount of surface visible with the ROV.

32) Sediment build-up on the floor.

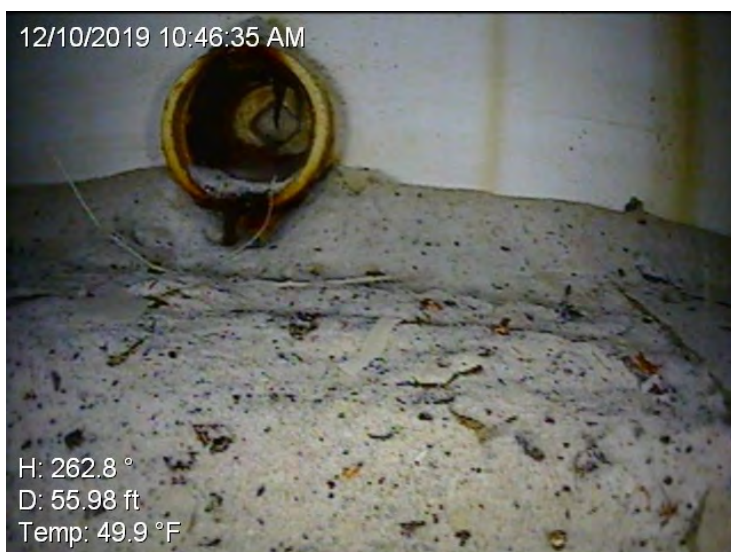
33) Same.

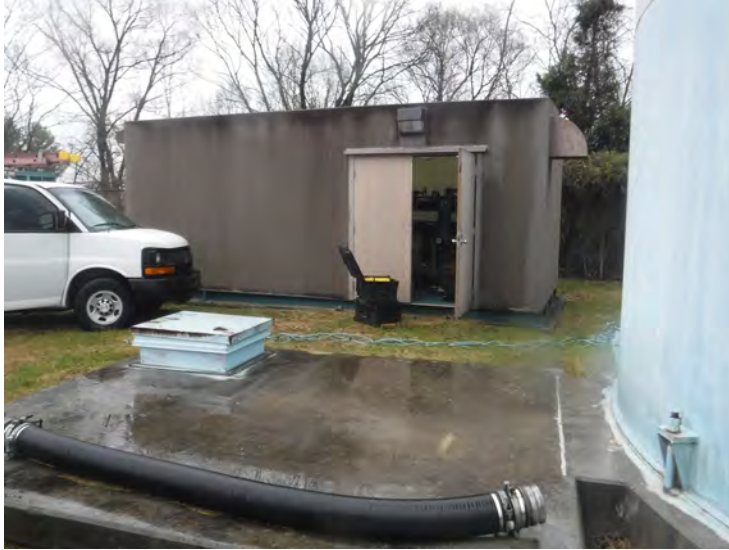
34) There is piping located in a building next to the tank.

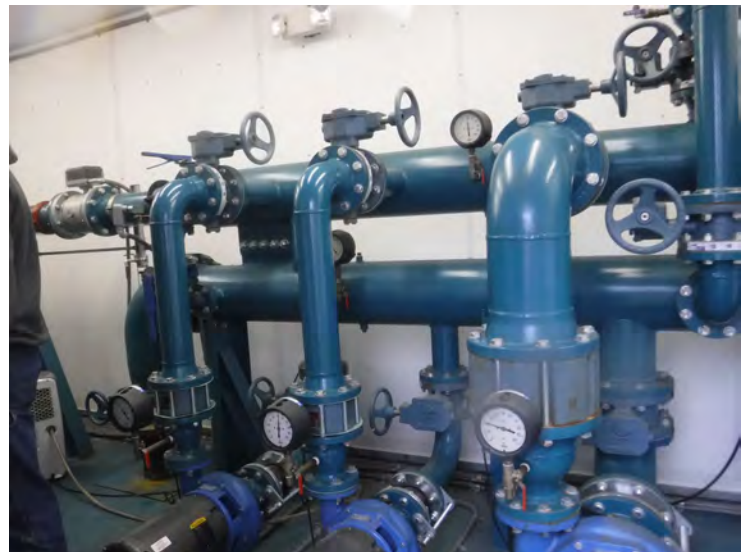
35) The coating on the piping inside the building is in good condition.

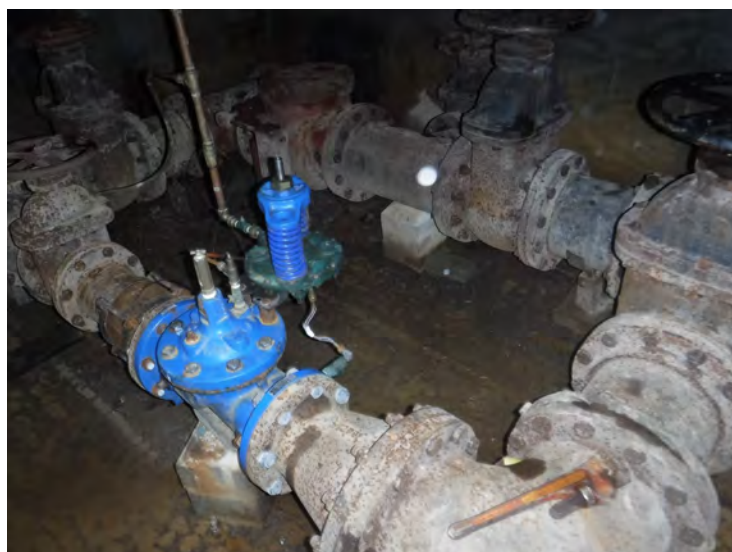
36) There are extensive coating failures on the pit piping.

Abrasive blast clean the pit piping to a commercial (SSPC-SP6) and repaint with an epoxy system. The estimated cost is \$5,000.
