Preliminary Maintenance Inspection  
2,000,000 Gallon Concrete Reservoir

Martinsburg, West Virginia

Inspection Performed: December 10, 2019  
Reviewed by Joseph T. Hoban, P.E.: February 12, 2020

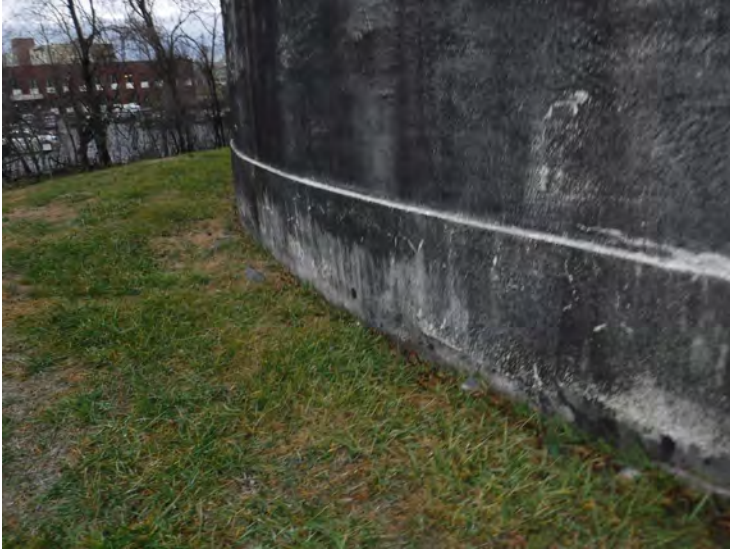
The sidewall is in fair condition overall. There are several cracks that run horizontally along the circumference of the sidewall. The edges of the cracks are intact. The cracks likely formed shortly after the original construction and are likely inactive. Efflorescence is present on the walls at all cracks. The efflorescence in the cracks is likely due to moisture vapor entering and exiting the cracks rather than leaking through the concrete. Slight buildup of efflorescence is common. Moisture migrating into and out of the crack will leave a deposit of efflorescence on the surface. This deposit can act like a scar sealing the crack.

1) The sidewall concrete is in fair condition overall.

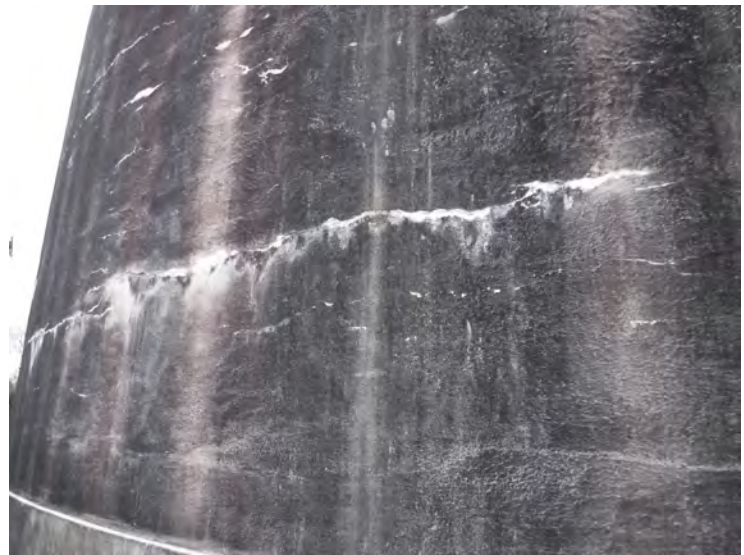
2) There is cracking with efflorescence present on the sidewall.

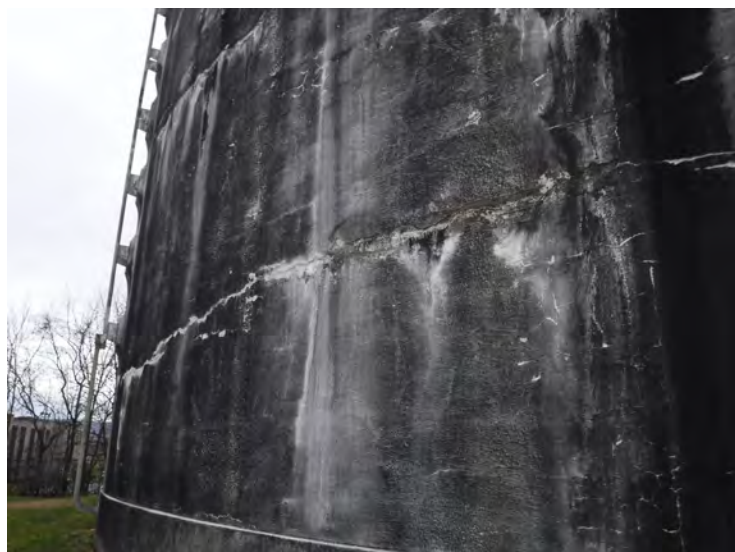
3) Same.

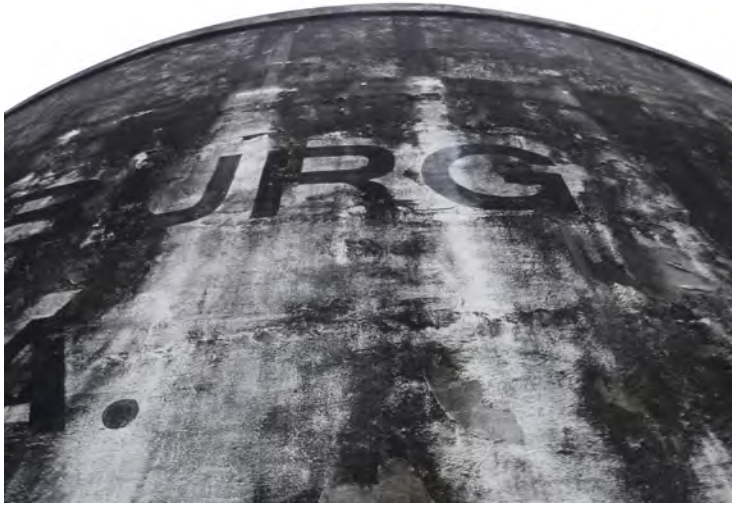
The sidewall coating is in poor condition with numerous failures. Primary modes of deterioration are erosion and delamination to the concrete. There is lettering that states "MARTINSBURG, WEST VA" on the sidewall in one location. The sidewall is covered with heavy mildew growth.

4) The sidewall coating is in poor condition.

The exterior coating is primarily for aesthetic purposes though the coating can provide some protection from weathering. If exterior coating is desired, the recommended procedure is to low-pressure water clean (3,500 to 5,000 psi) the exterior to remove any delaminating or flaking coating and any contaminants.

The exterior would be overcoated with two full coats of acrylic. The purpose of this procedure is to remove all the poorly adhering topcoat, leaving the tightly adhered coating in-place. The reservoir would be removed from service during the painting project. This is necessary to reduce moisture condensation on the surface. The estimated cost to overcoat with an acrylic system is \$100,000.

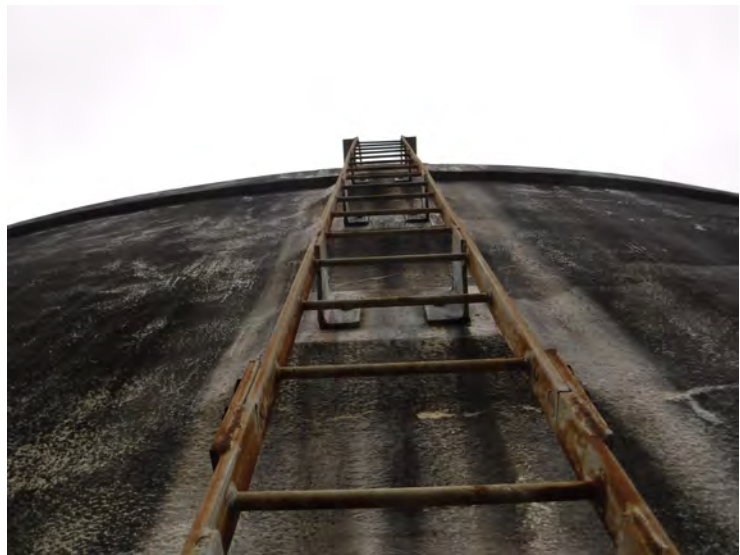
The exterior sidewall ladder starts at ground level and extends up to the roof. The ladder is not equipped with a fall prevention device. There is no vandal guard on the sidewall ladder.

5) The exterior ladder is in good condition. The ladder is not equipped with a fall prevention device.

Install a rail-type fall prevention device on the exterior ladder. The estimated cost is \$4,000.

Install a vandal guard on the exterior ladder. The estimated cost is \$2,000.

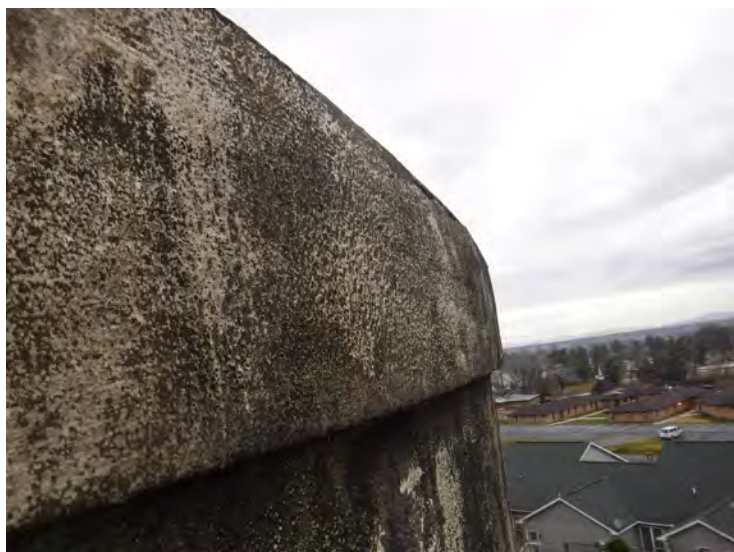
6) The tension ring at the top of the sidewall is in good condition.

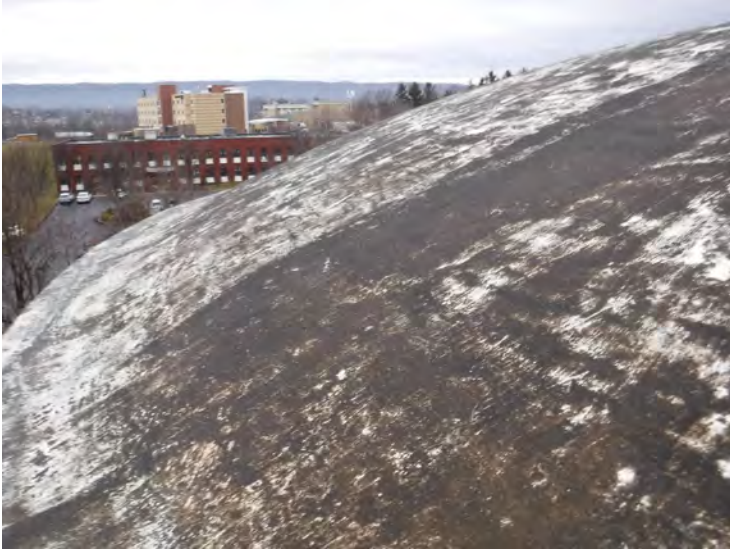
The roof is in good condition overall. There are a few cracks that are randomly located throughout. The edges of the cracks are intact. The cracks likely formed shortly after the original construction and are likely inactive. No efflorescence is present on the roof at the cracks.

7) The roof concrete is in good condition overall.

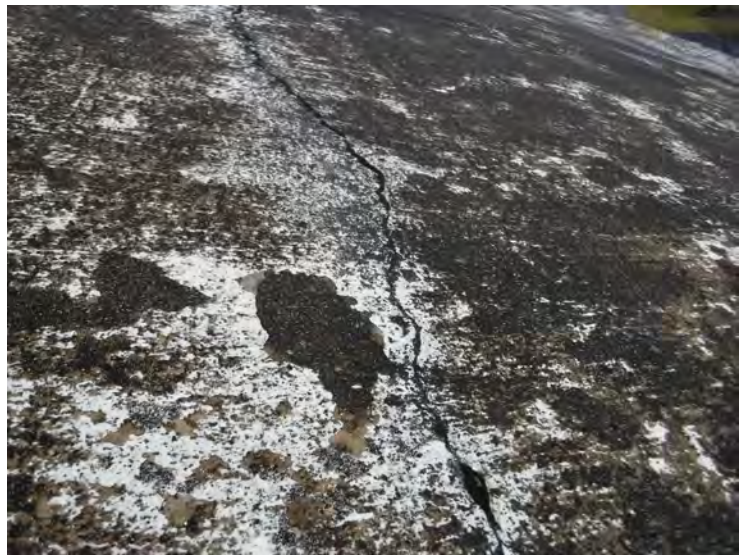
8) There is cracking on the roof.

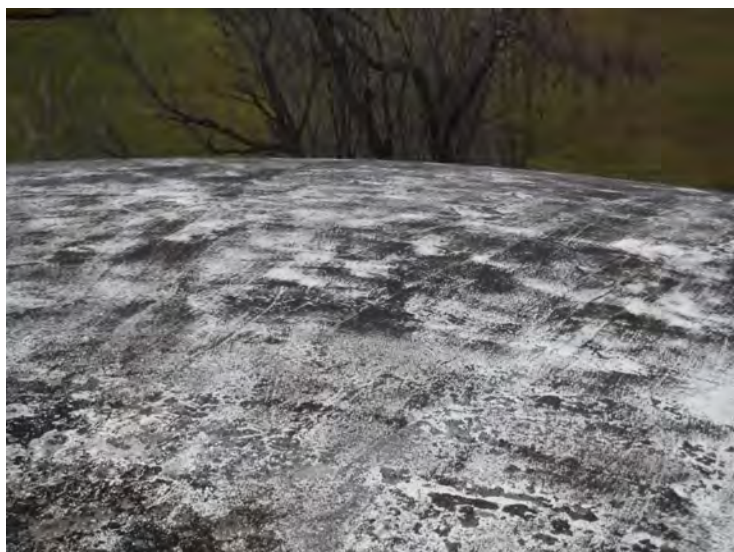
The roof coating is in poor condition with numerous failures. Primary modes of deterioration are erosion and delamination to the concrete.

9) The roof coating is in poor condition.

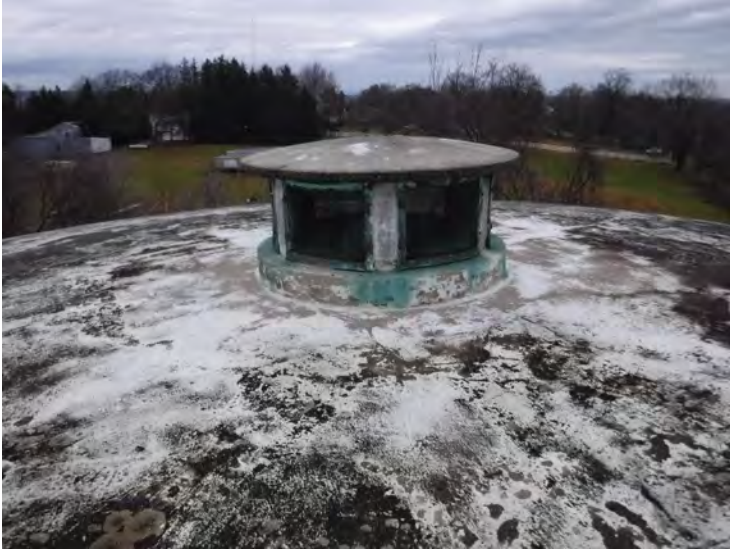
There is one roof vent that is in good condition. The vent is 36 inches in diameter with a flow-through design. There is a vertical screen on the roof vent that is in good condition. The screen is not covered to prevent rain from entering the wet interior. The West Virginia DEP requires a shroud cover over the vertical screens.

10) The roof vent is in fair condition. The vent does not have a rain shield.

Replace the roof vent with a properly shielded vent. The estimated cost is \$7,000.

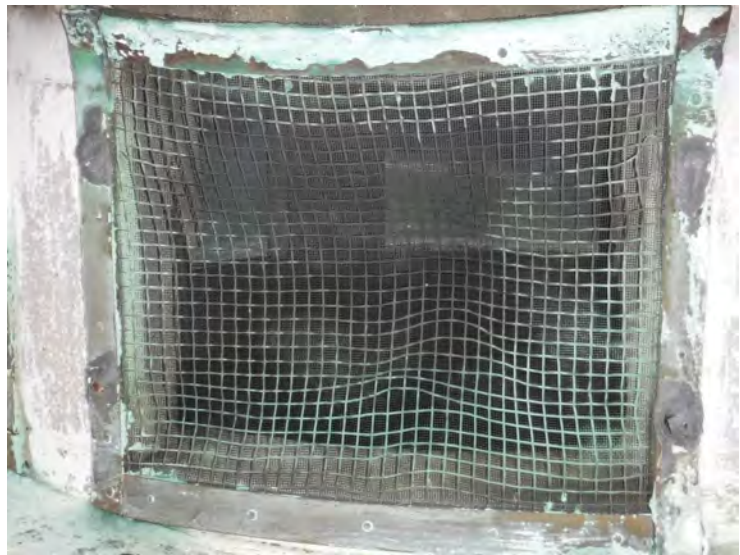
11) The vent screens are in fair condition.

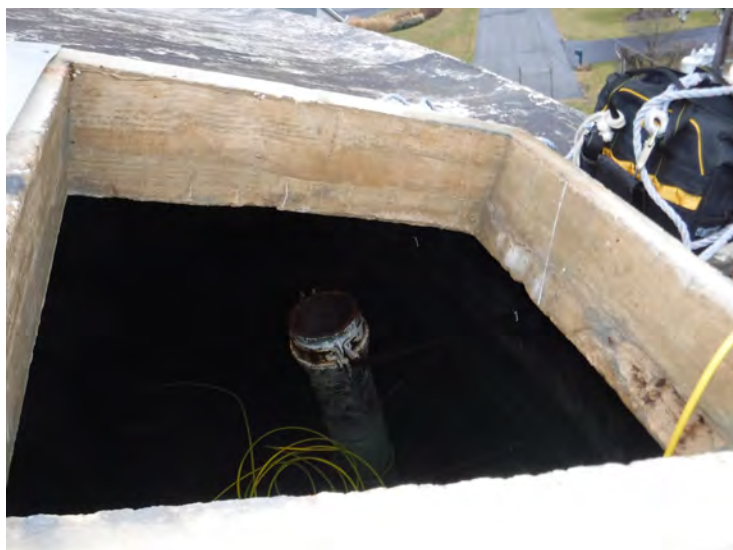
12) The concrete roof hatch curb is in good condition.

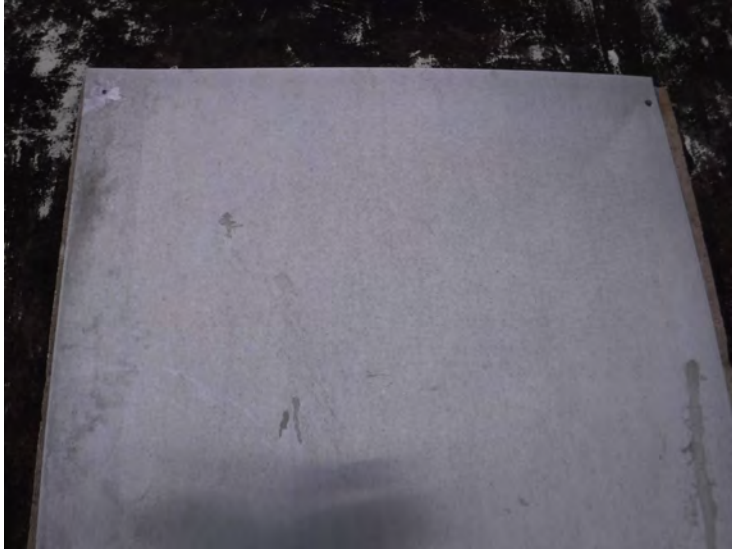
piece of flat sheet metal fastened to the concrete curb. The cover does not meet West Virginia DEP requirements.

13) The roof access opening is covered with a flat piece of sheet metal.

Replace the cover with a new 36 inch prefabricated hatch that has an elevated neck and overlapping cover with a lockable hasp. The estimated cost is \$10,000.

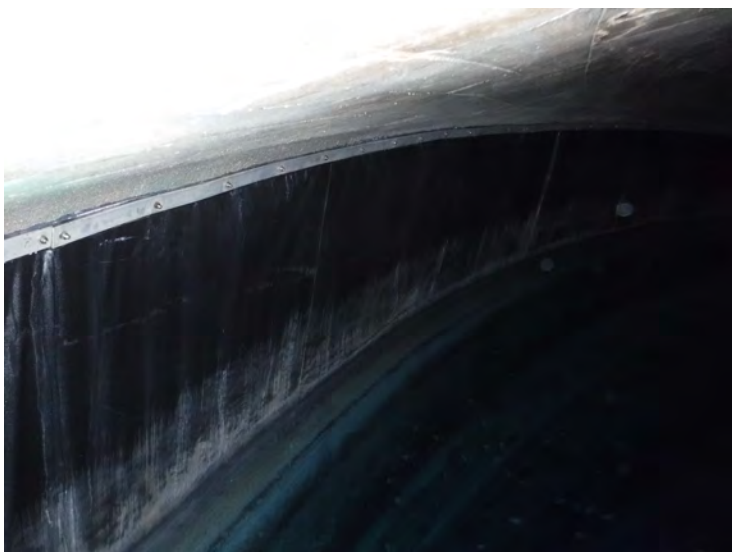
15) The sidewall is covered with a rubber membrane. The membrane is in good condition.

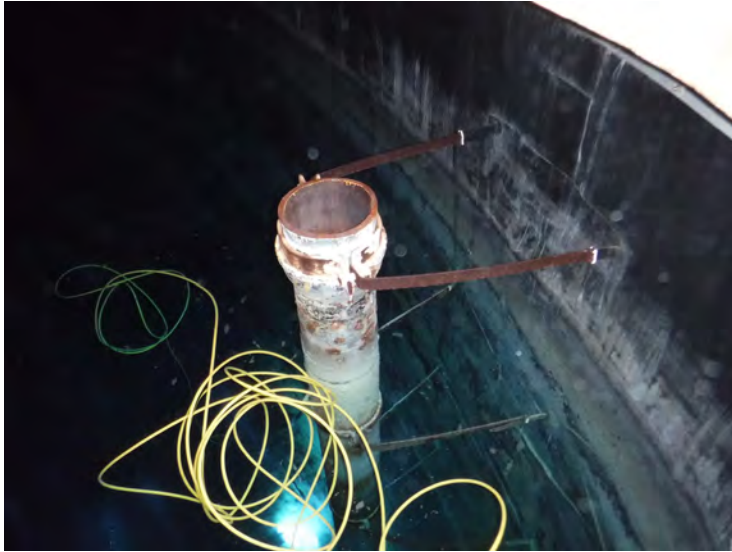
The overflow pipe is supported by braces on the sidewall. There is no coating on the braces and there is minor corrosion.

16) The overflow intake is in good condition. There is corrosion on the braces.

Remove the existing overflow pipe and install a new pipe that exits the upper sidewall and route along the exterior sidewall to a splash pad. Orient discharge vertical maintaining a 12-24 inch air gap and install a screened flap gate. This will bring the overflow pipe discharge into compliance with current West Virginia DEP requirements. The work would need to be performed by the tank manufacturer to ensure the wires on the sidewall are avoided during installation. The estimated cost is \$8,000.

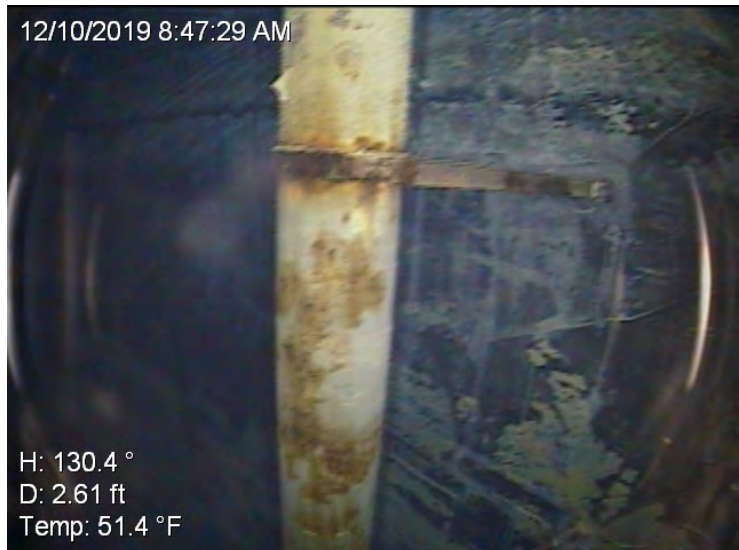
17) The overflow pipe coating is in fair condition.

Repaint the wet interior piping when the overflow modification is made. The cost would be incidental to the overflow modification.

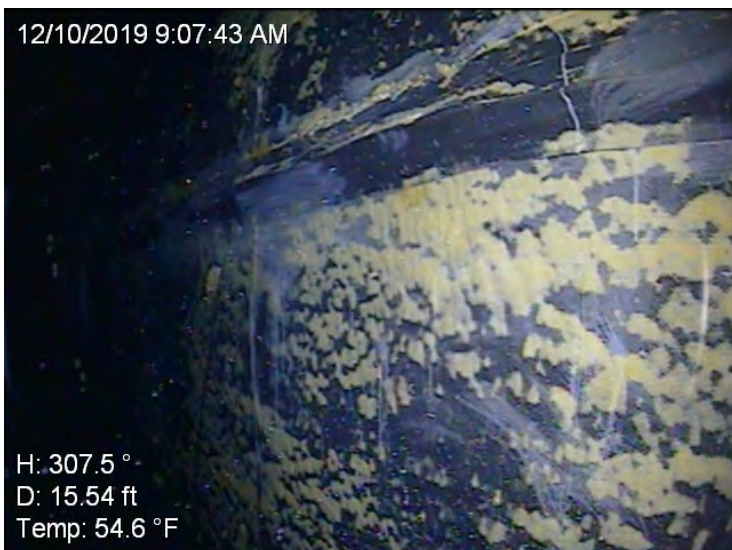
18) The rubber membrane on the sidewall is in good condition.

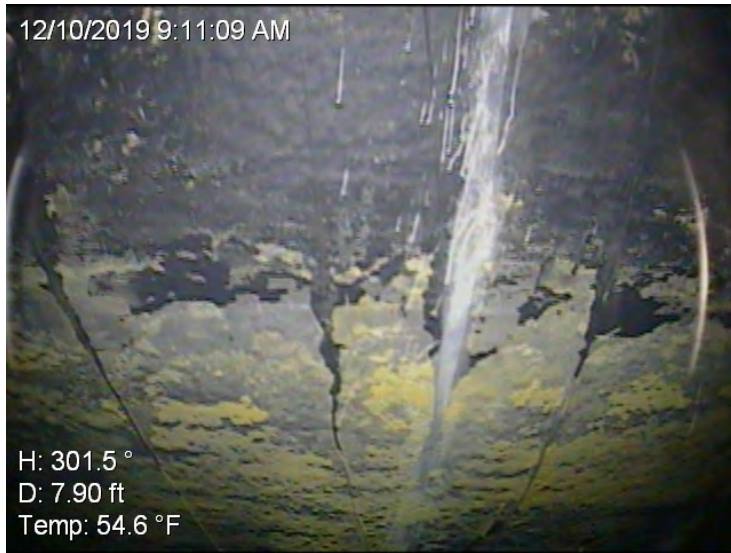
19) Same.

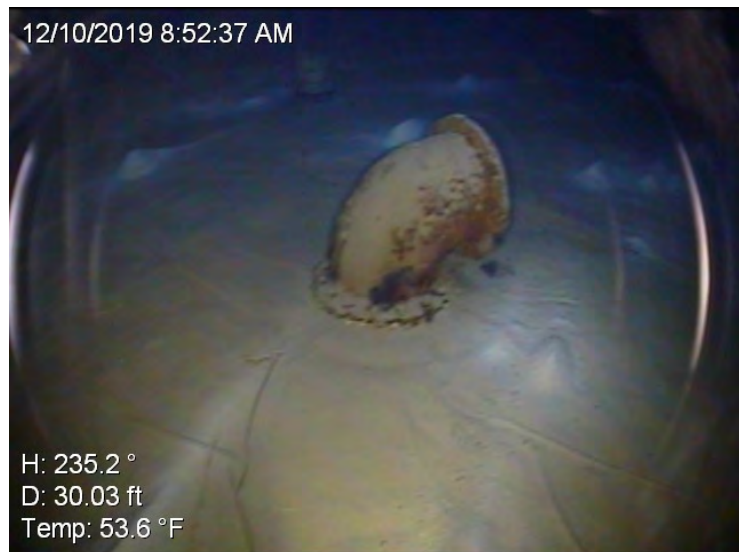
20) The fill/draw pipe is in good condition.

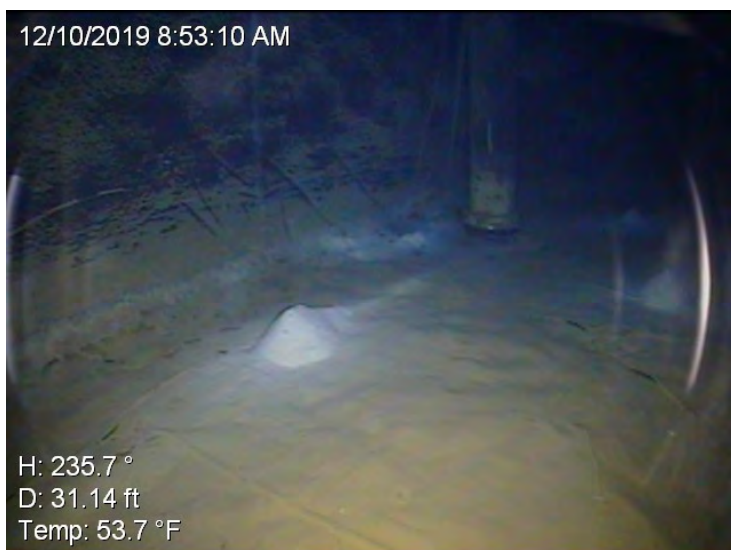
Interior floor comments: **There is uniform sediment build-up on the floor and approximately 30 sediment piles on the floor**

21) The floor was covered in sediment.
