**City of Martinsburg**  
232 N Queen St, Martinsburg, WV 25401

# **Market House Building Evaluation**

July 30, 2021

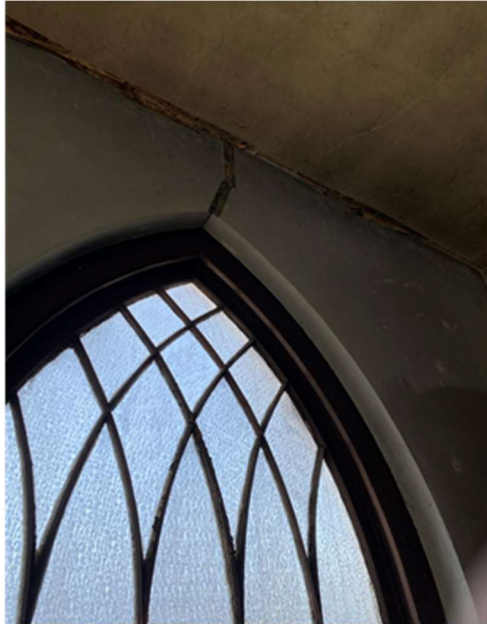
Minor settlement over time of the building has occurred and the exterior walls show evidence of this through cracking. These stresses will build up at sharp wall openings and cause cracking. If more extreme settlement were occurring you would see stairstep cracks in the exterior brick. As such, there was no evidence of such settlement.

Typical crack on exterior wall

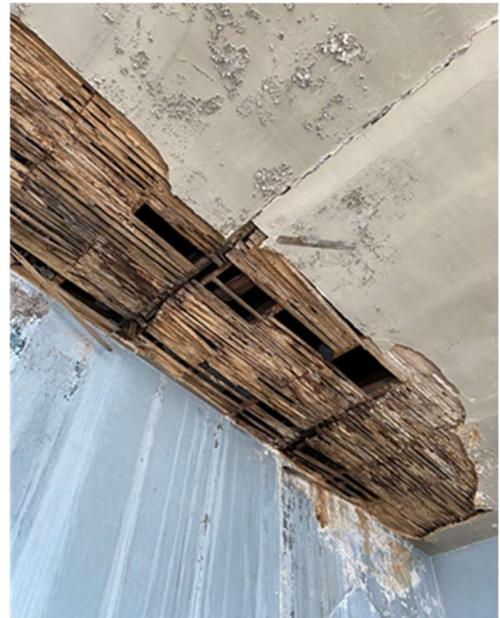
There are several areas where roof leaks have occurred and deterioration of the ceiling and walls have occurred. These areas should be removed and replaced to restore weathertight conditions. It is not believed that there are current roof leaks as there is a recent installed EPDM roof in place.

Wall and ceiling deterioration

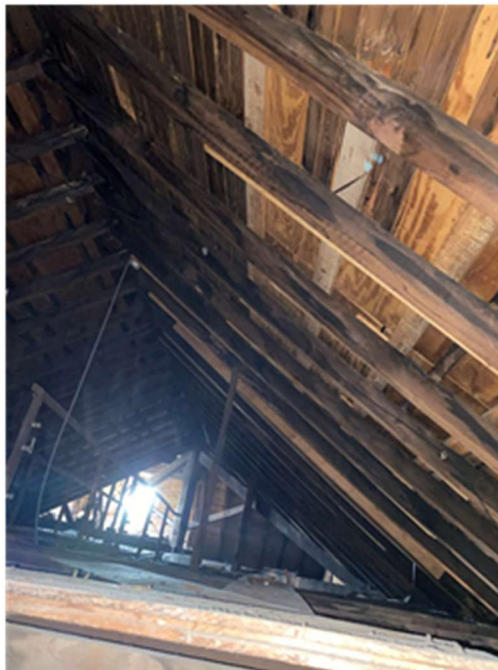
The wood roof structure appeared to be in serviceable condition but any members damaged by previous water leaks should be reinforced or replaced. will also need to be removed and replaced. See Exhibit #4. The attic space could only be accessed visually through a small ceiling opening by holding a cameral through the opening.

Typical roof structure

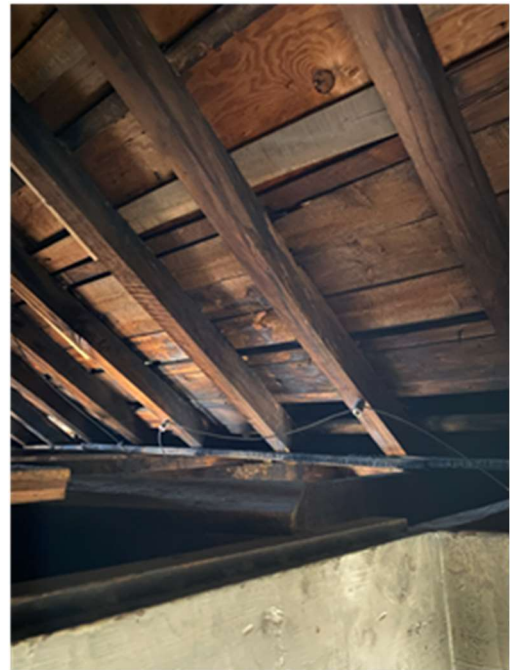
Typical roof bearing

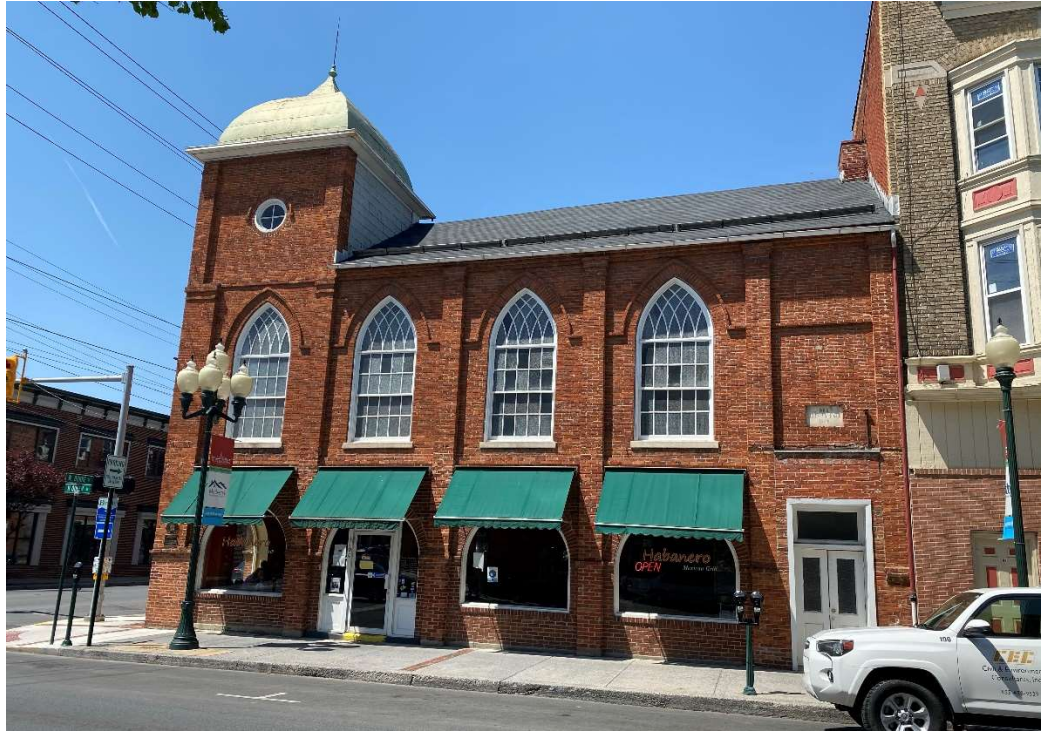
The exterior masonry load bearing walls of the Market House appear to be primarily original construction and are generally in very good condition particularly given the building's age. This is particularly true for both the Queen and Burke Street elevations and the West Side alley elevation. The North Side alley was not fully accessible at the time of the visit but it also appeared to be in serviceable condition although not as aesthetically pleasing as the other elevations.

Queen Street Elevation

Exterior repair on the two primary elevations is very limited with minor selective repointing to prevent water infiltration and subsequent freeze/thaw damage. From visual inspection only, the stone base and window sills also appear to be in good condition. With limited visibility of actual second floor window conditions, caulking of joints is always recommended from a preventative maintenance perspective.

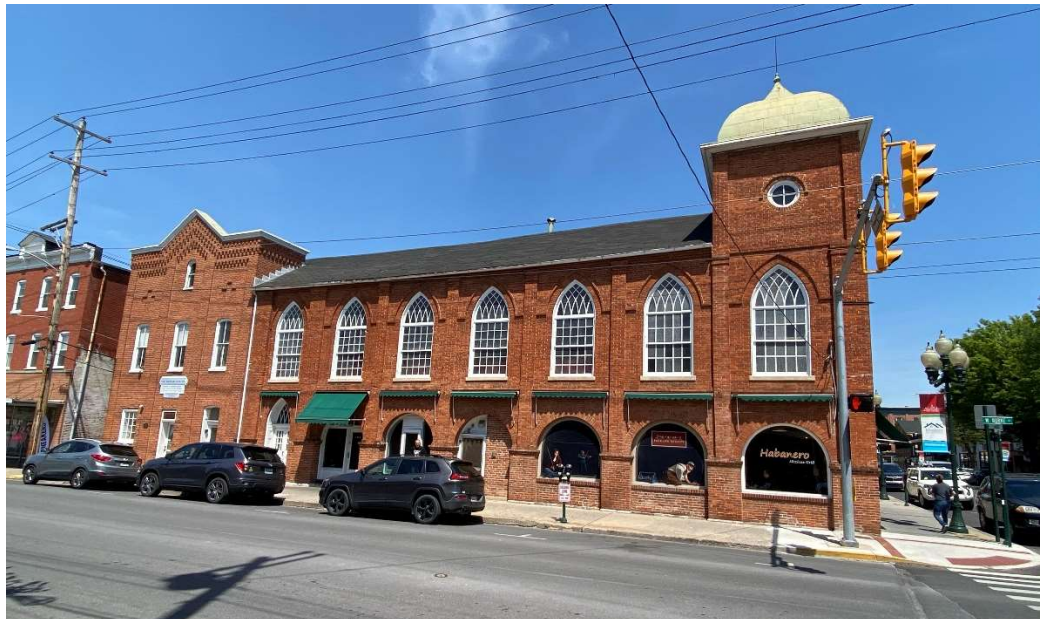
Burke Street Elevation

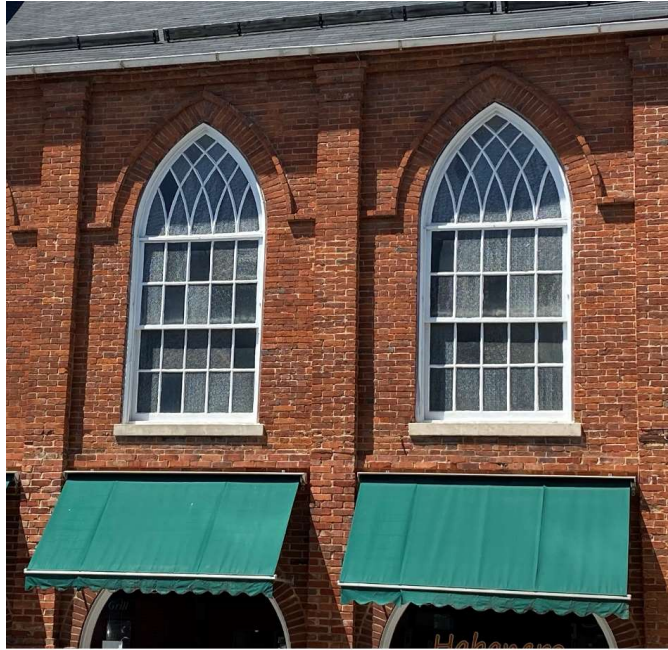
Solar controls are currently being utilized to control heat gain at the Queen Street tenant space to minimize the air conditioning requirements of that space. Such controls were apparently part of the original construction in the form of a wood frame canopy. This can be utilized at other windows and door openings throughout the building. However, it may be problematic to provide solar controls for the feature windows without harming the aesthetic appearance of this historic structure.

Queen Street Elevation Pointed Arched Windows and Solar Controls

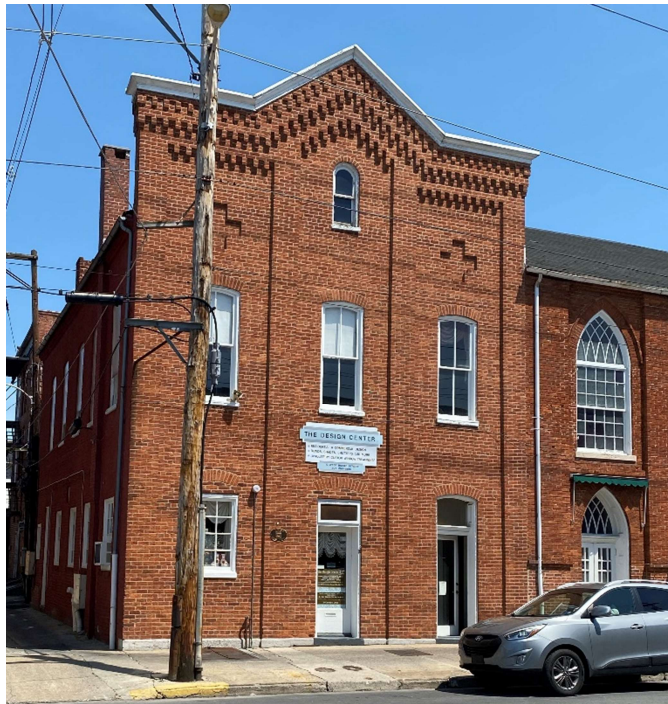
Windows at the second floor and the west end addition all appear to be original painted wood frame, single pane glazed, divided light windows. The second-floor elevations feature large gothic style pointed arch windows located in each of the ballrooms. These windows are approximately 5'-0" wide and approximately 11'-0" to the top of the pointed arch. At some point throughout its life, individual panes of glass have been replaced given the patchwork look and color variations of many panes of glass particularly on the Queen Street elevation. Most the windows within reach of the floor were constructed with operable sashes. Many

of the sashes are no longer operable but it appears that reconditioning can restore operability.

Burke Street Elevation Windows

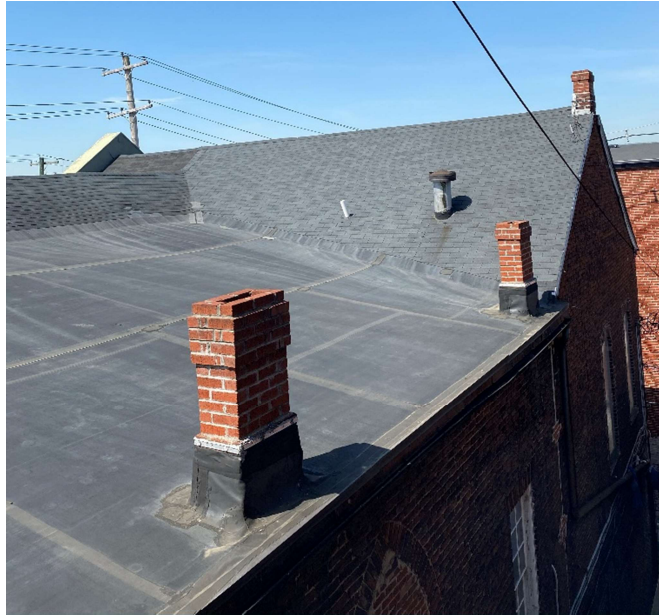
Rubber Membrane Roofing and Chimney Flashing

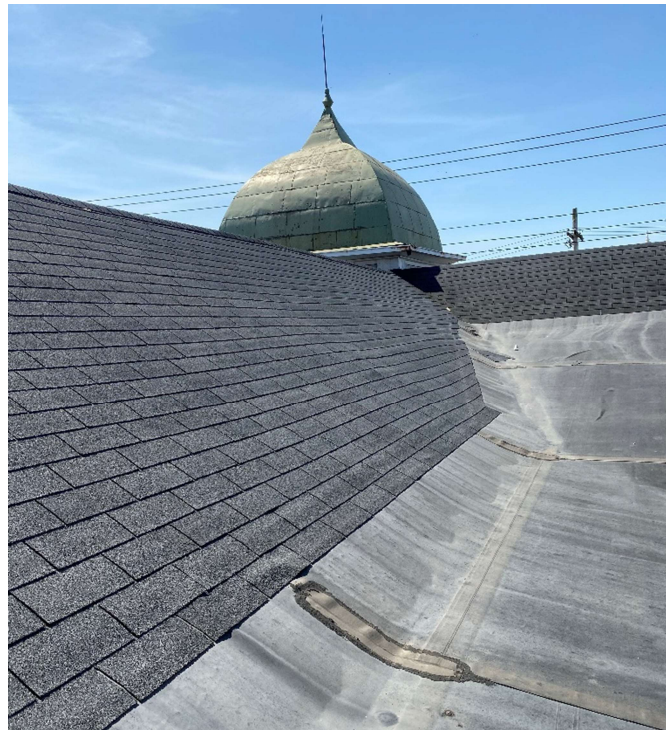
Asphalt Shingles and Rubber Membrane

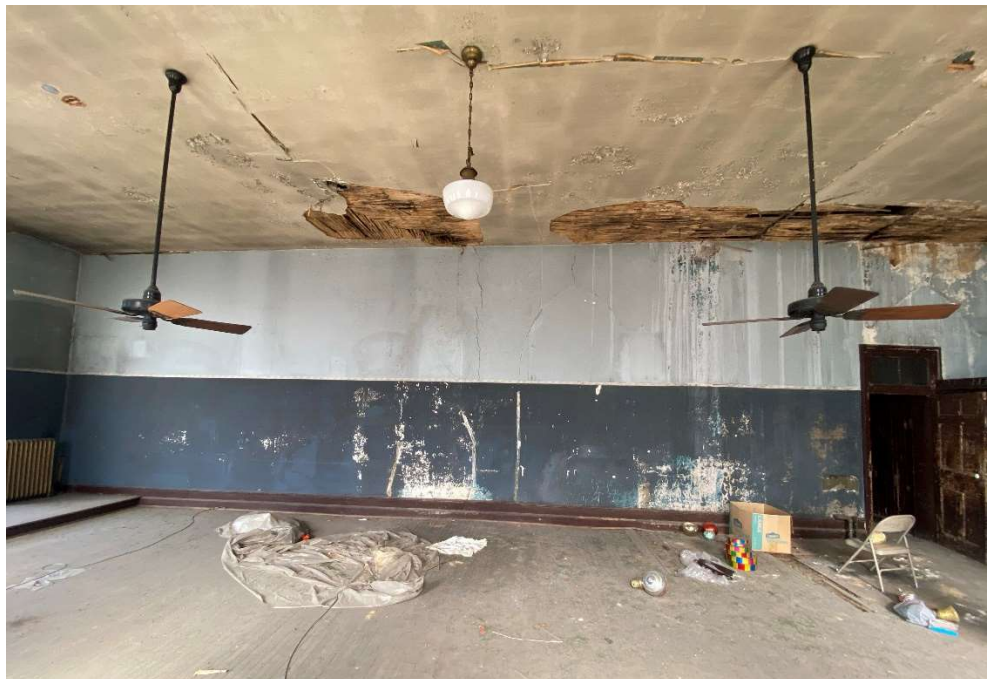
Within the buildings recent history, the roof was in need of repair which subsequently caused damage to the interior, primarily on the east end of the second floor. Without access to the attic space, it is unknown if any significant damage to the roof structure resulted. With limited visibility through a ceiling hatchway, it did not appear that such damage occurred. There is also no noticeable sign from the exterior that damage had occurred. The roof covering, consisting of asphalt singles and rubber membrane roofing, appeared to have been replaced recently which rectified any leaking that occurred in the past. There was no discernable means of determining if insulation was added above the roof framing and decking. However, it is clear that no insulation exists under the roof decking or between the rafters above the East End Ballroom.

West wall of the East End Ballroom showing water damage

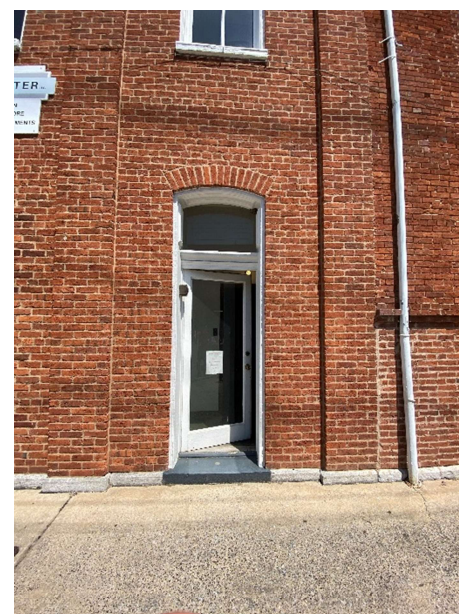
The Queen Street tenant space entry door width is suitable for accessibility but the Burke Street tenant space entry has a masonry opening at 3'-0" which is less than the required width when including the current door and frame. This is a situation where the city will need to determine if the historical fabric must be maintained. Otherwise, creative detailing of a door replacement maybe able to accommodate the full width of the opening.

Burke Street Tenant Space Entrance

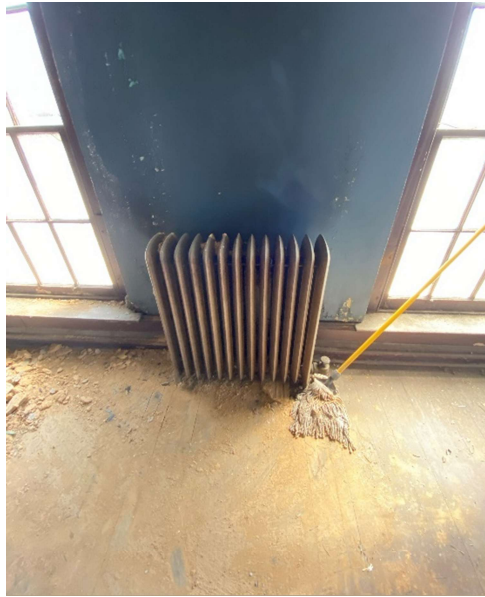
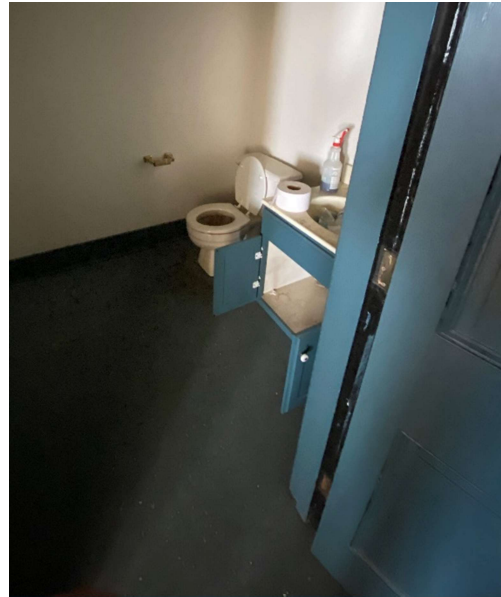
Radiant Heater at East End Ballroom    Single Toilet Facility on the 2<sup>nd</sup> Floor

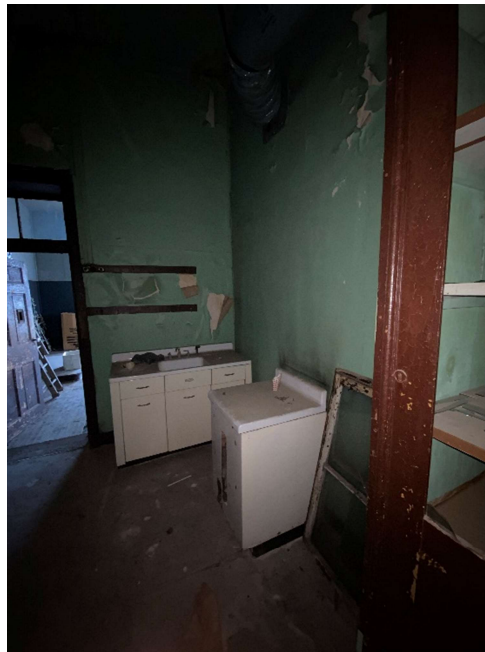
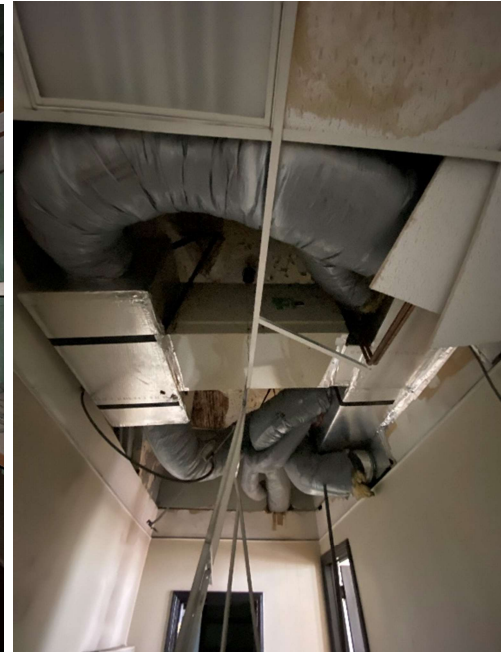
Kitchen Area near East End Ballroom    HVAC Unit with Distribution Ductwork
