# **Dixon Engineering, Inc.**

Preliminary Maintenance Inspection  
1,500,000 Gallon Hydropillar  
(Boyd Orchard)

Martinsburg, West Virginia

Inspection Performed: September 19, 2019  
Reviewed by Joseph T. Hoban, P.E.: February 24, 2020

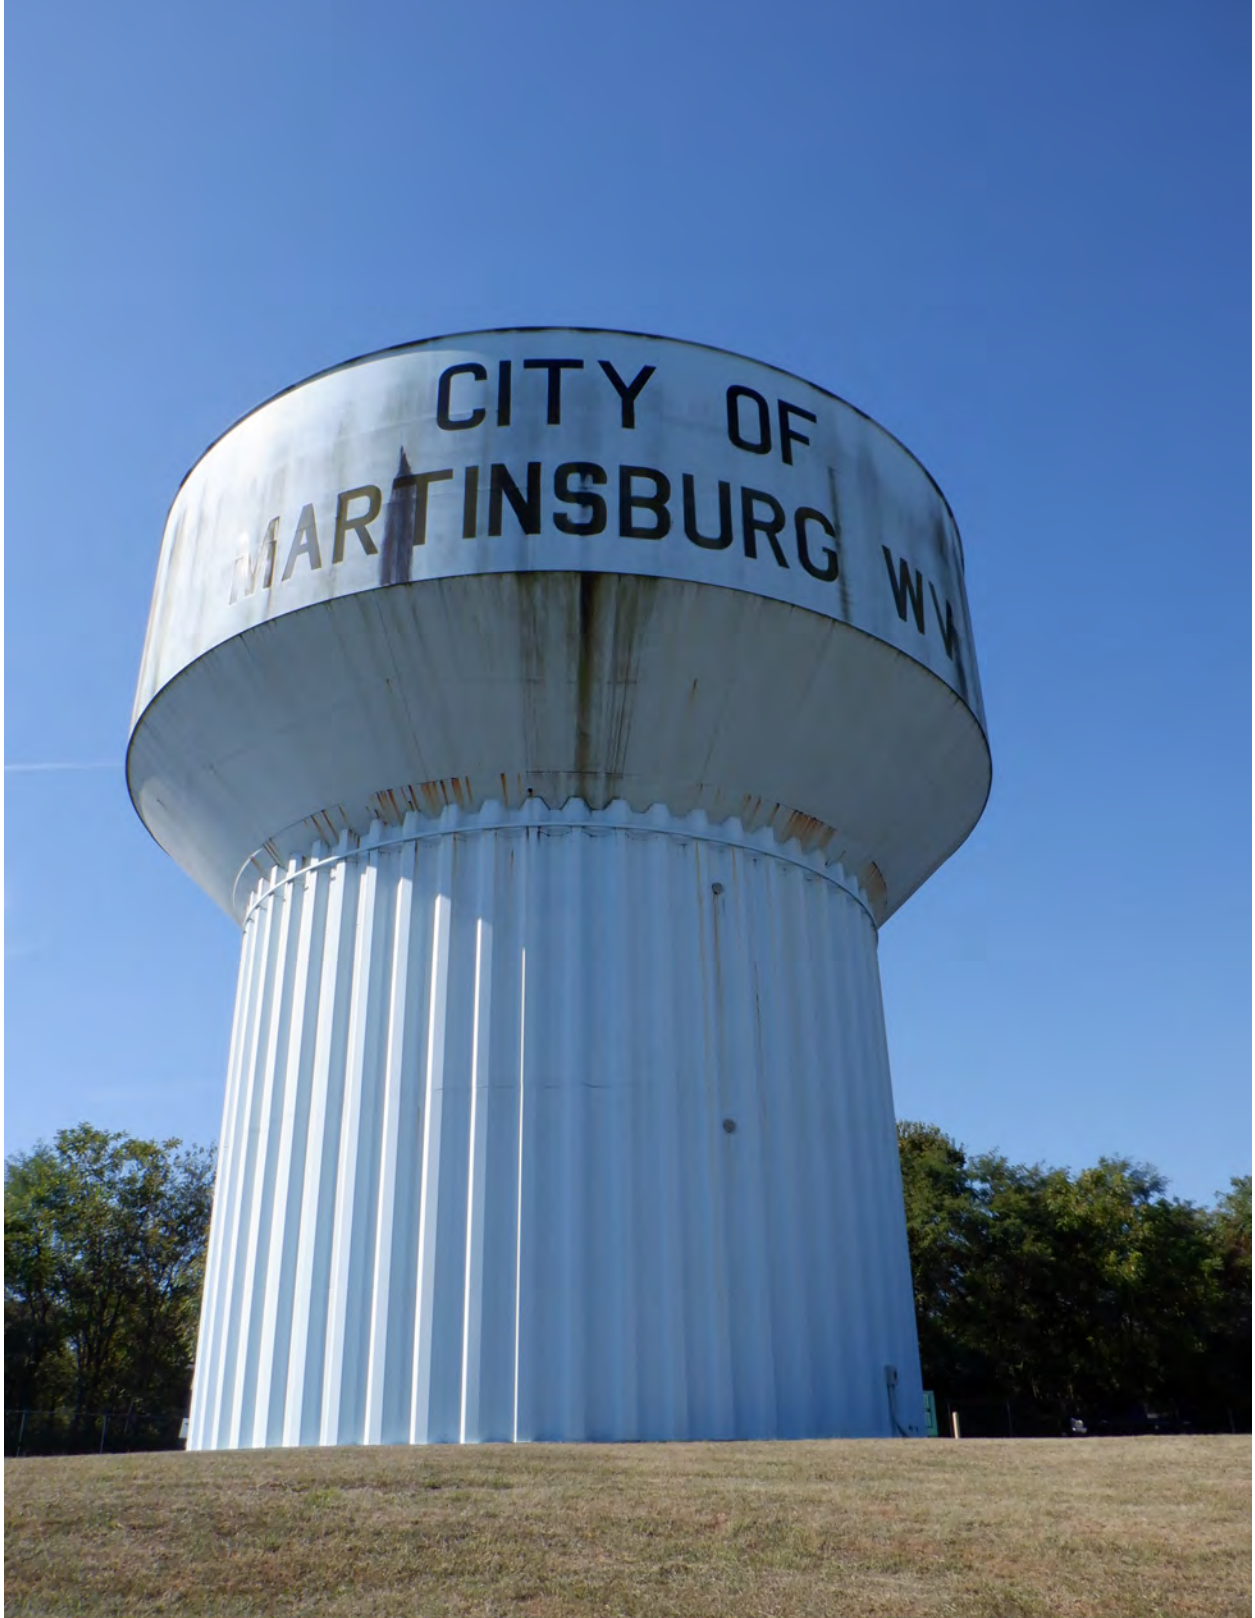
1,500,000 gallon fluted column (Boyd Orchard) owned by the City of Martinsburg, West Virginia.

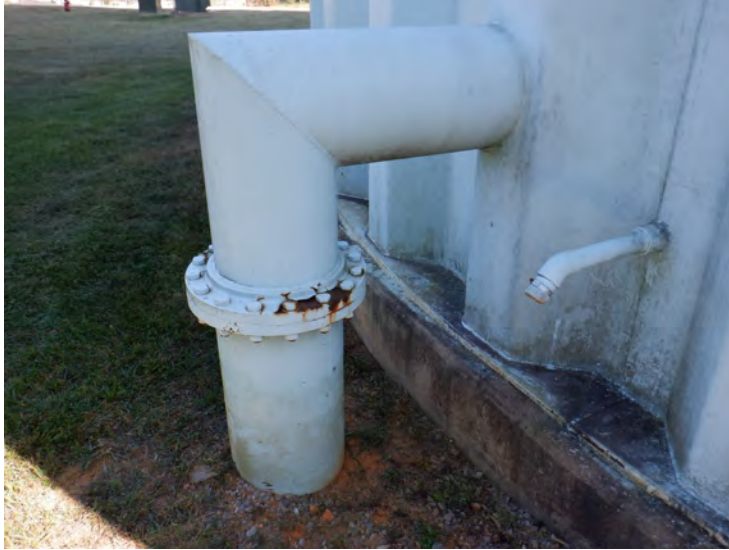
4) The overflow pipe elbows downward and routes directly underground.

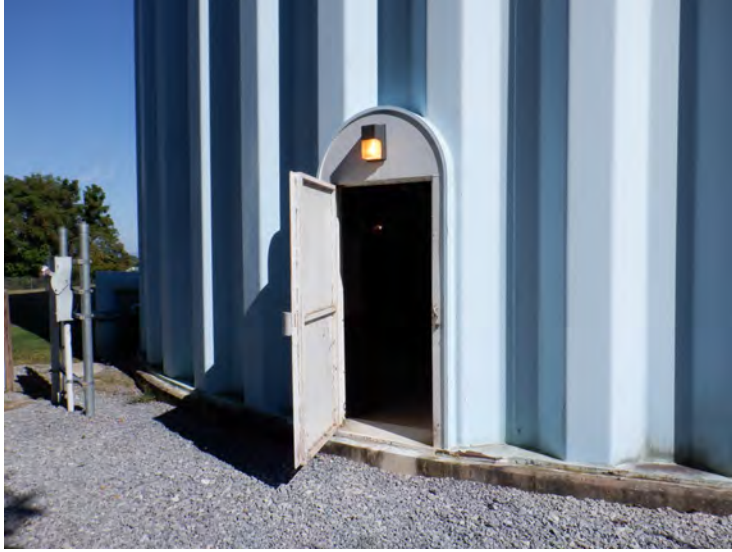
7) The service door was properly locked upon arrival.

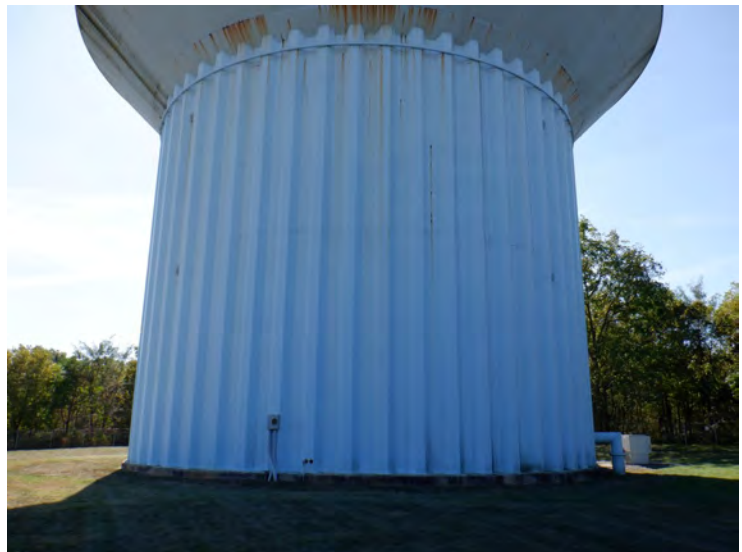
9) The coating on the column has faded significantly.

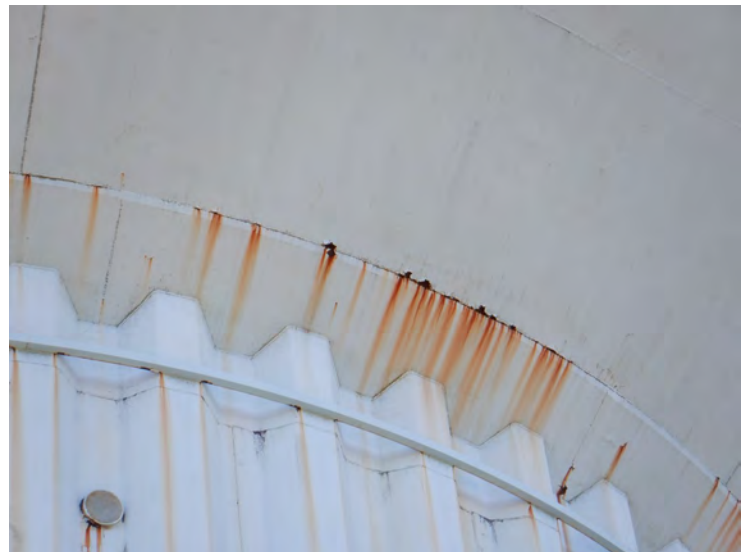
12) Coating failures are on both the weld seams and randomly throughout the flat panels.

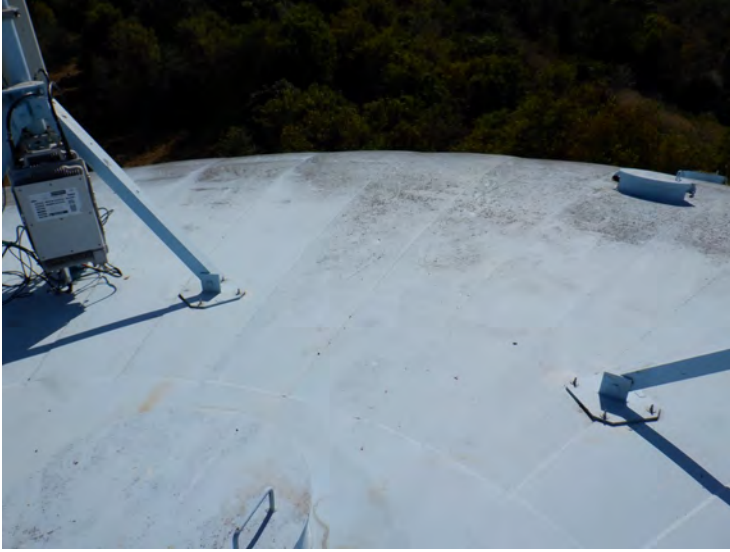
16) The roof coating is in fair condition.

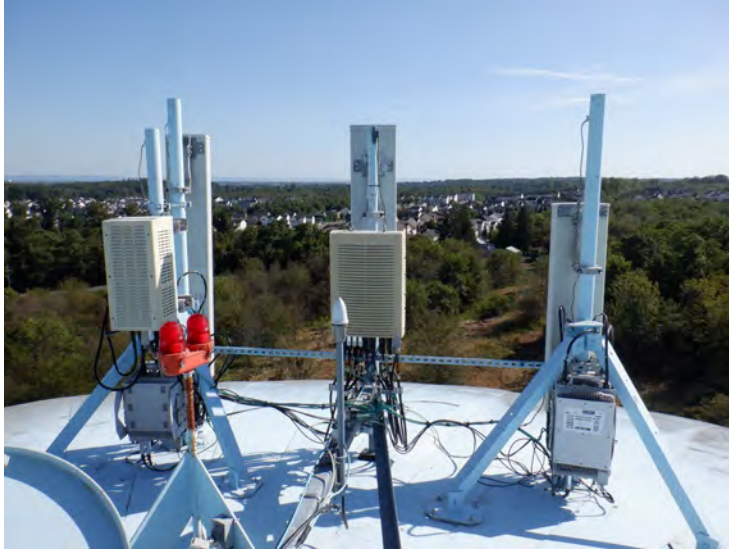
19) Roof antennas are mounted to tripods bolted to the roof.

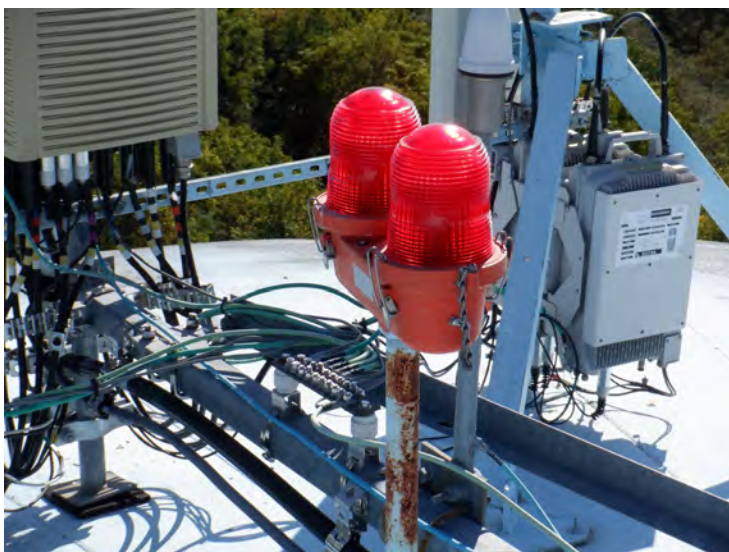
21) The double red aviation light is attached to a free standing pole.

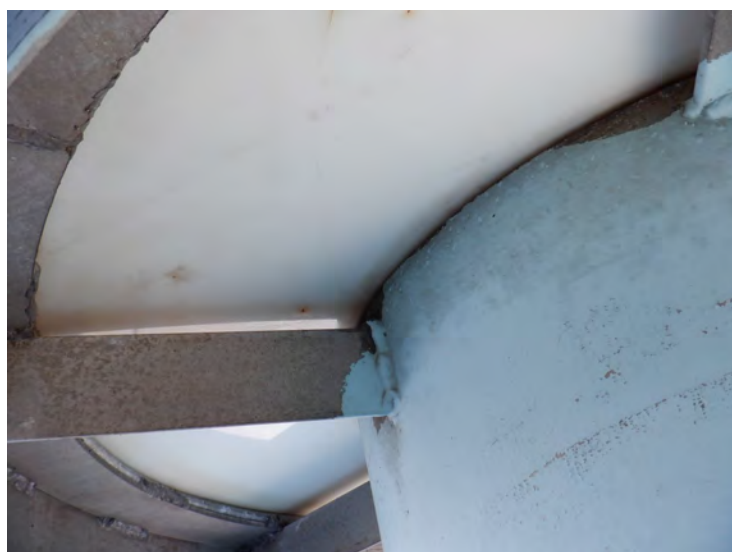
24) The pressure plate on the vent is free to move without interference.

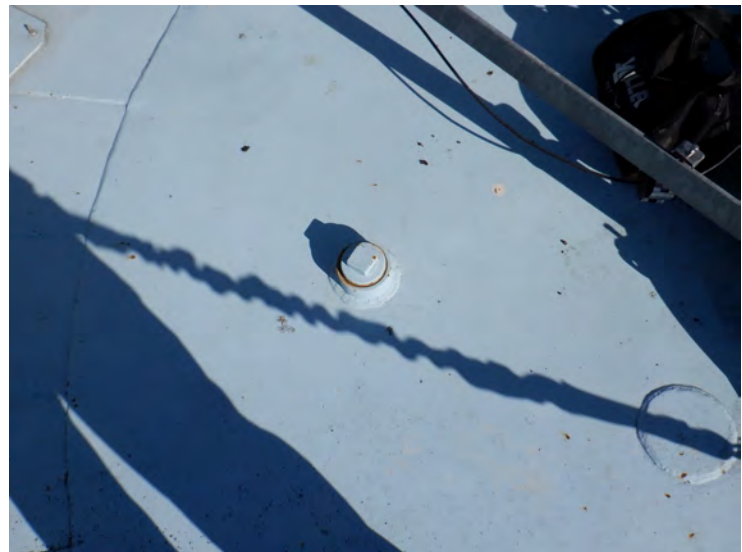
26) There is minor corrosion on the roof coupling threads.

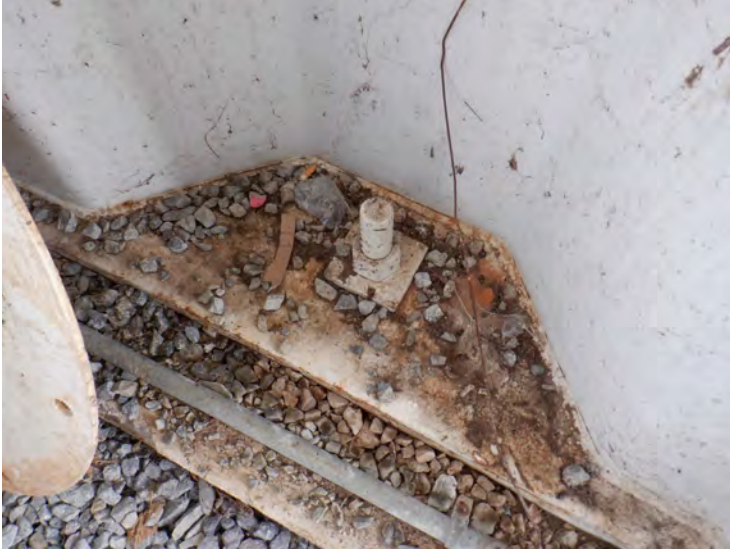
28) The anchor bolts are in good condition.

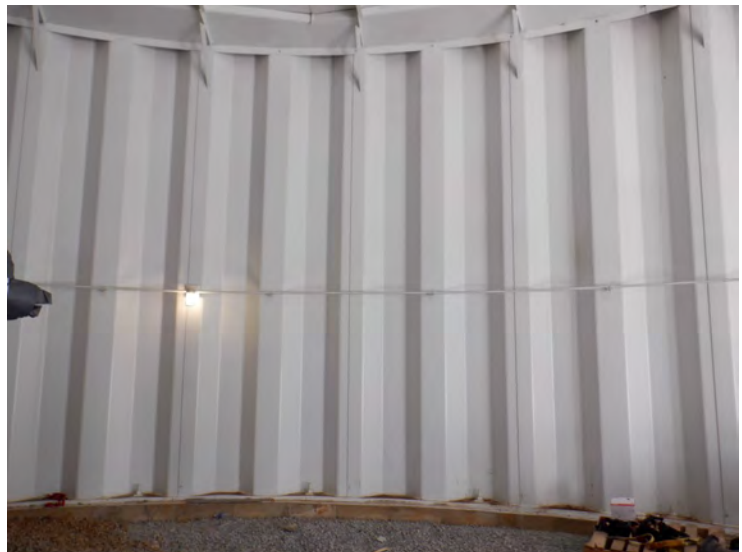
29) The coating on the column below the condensate platform is in good condition.

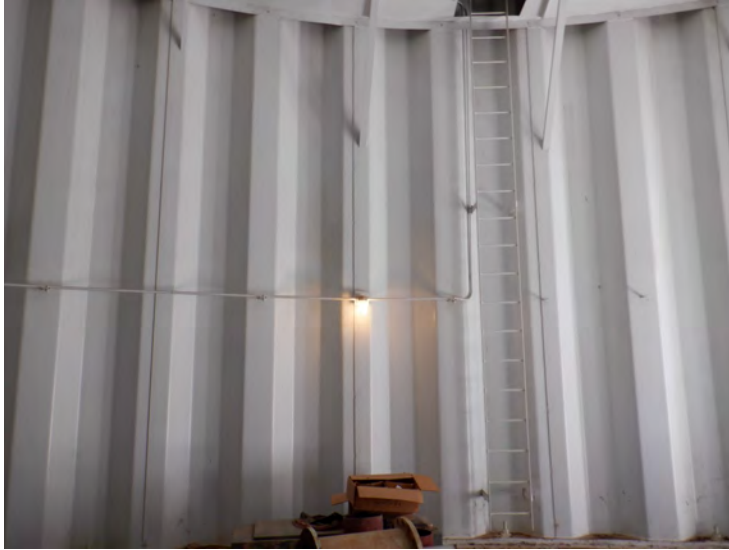
31) The lights were functioning during the inspection.

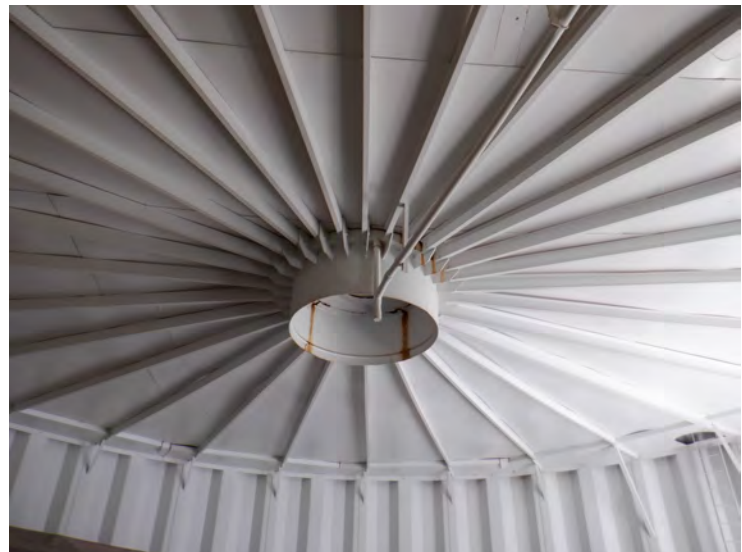
32) The coating on the underside of the condensate platform is in good condition.

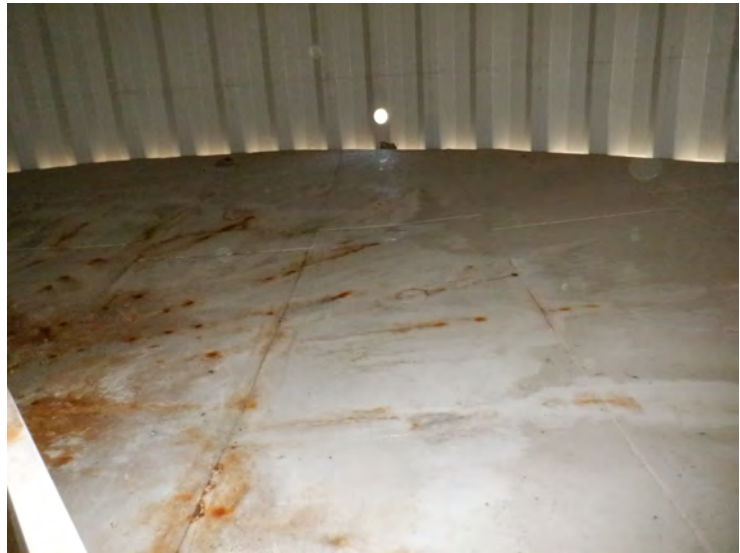
Platform comments: **Several large coating failures, 4 x 4 foot covered opening in the platform**

35) The coating on the condensate platform is in poor condition.

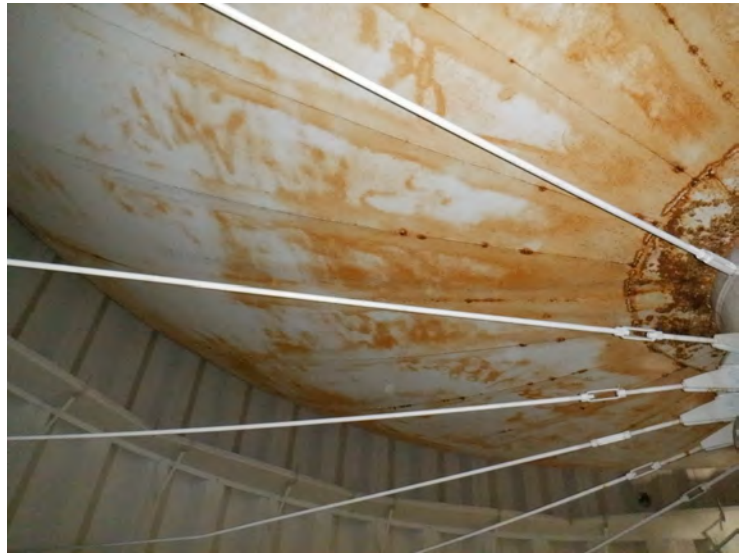
Bowl comments: **Extensive rust bleedthrough**

41) There is rust bleedthrough throughout the bowl.

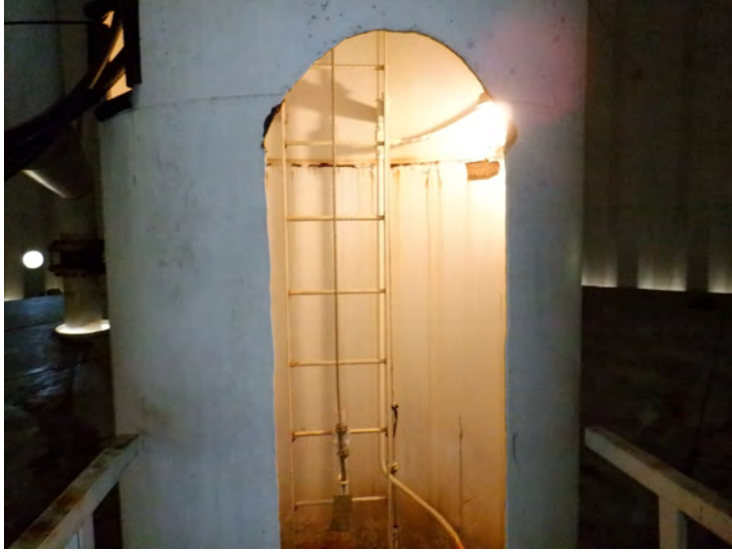
43) The access tube ladder is equipped with a cable style fall prevention device.

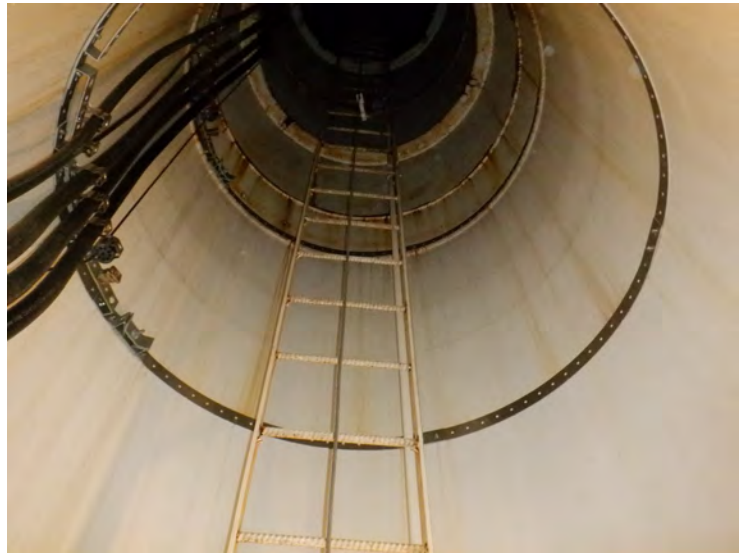
Access tube comments: **Extensive coating failures, most are at or near the weld seams**

44) The coating in the access tube is in poor condition overall.

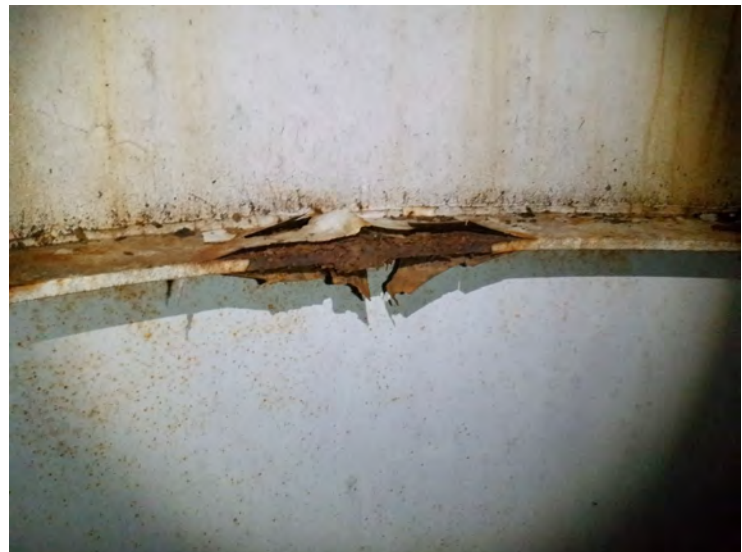
47) There are spot coating failures with rust undercutting on the access tube stiffeners.

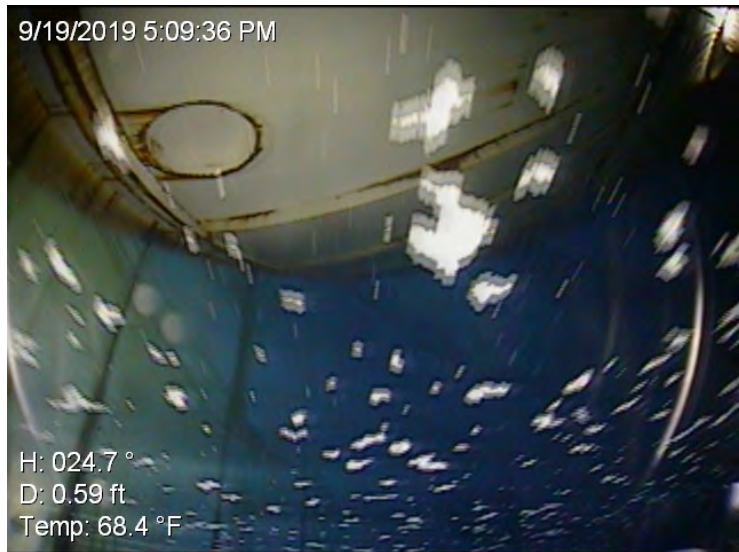
53) Weld burns and spot coating failures to the substrate on the wet interior roof panels.

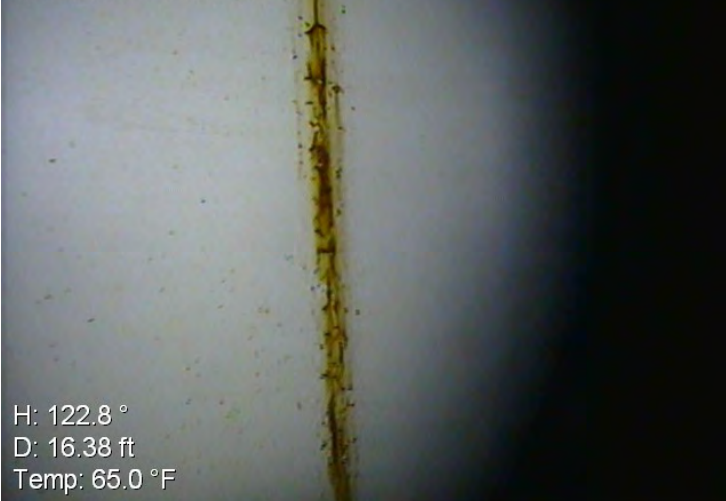
58) Spot coating failures to the substrate on a wet interior sidewall weld seam.

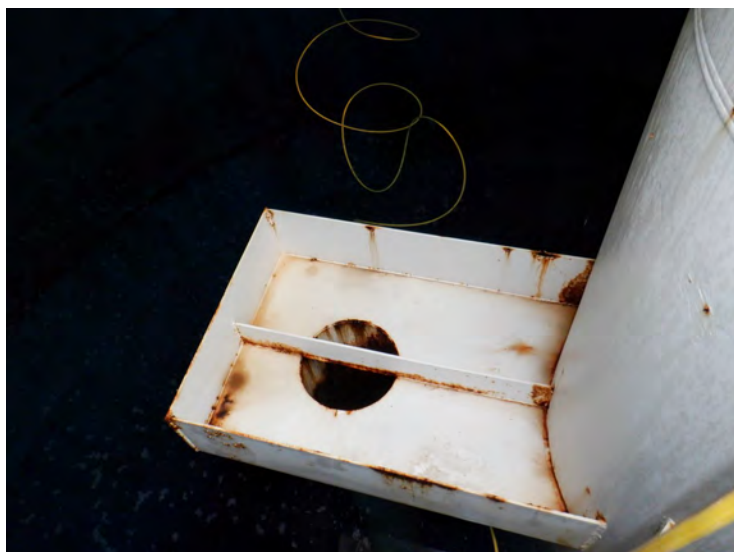
67) Spot coating failures to the substrate at the top of the access tube above high-water line.

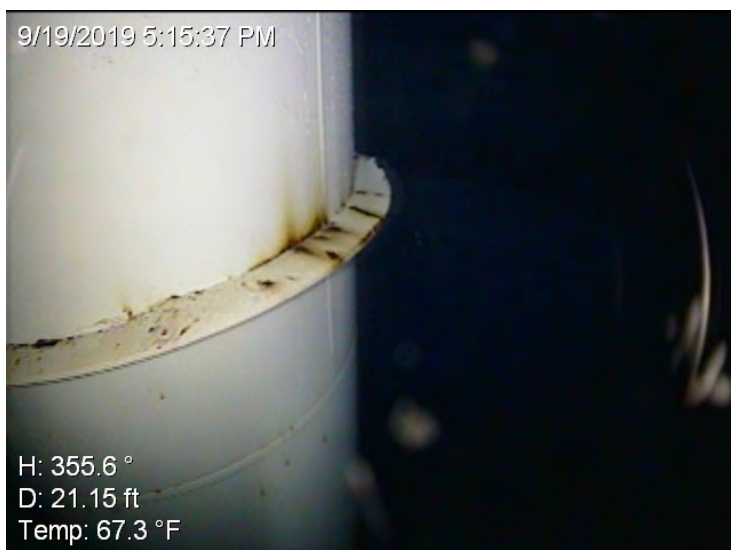
72) Spot coating failures to the substrate on an access tube stiffener.

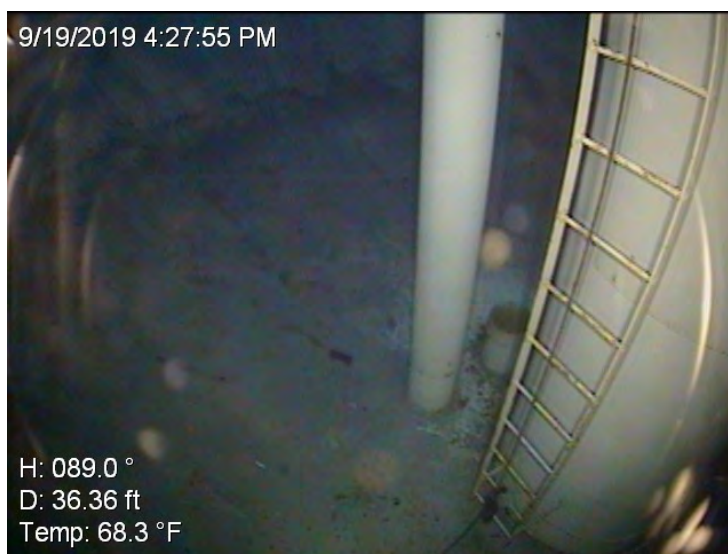
74) The wet interior ladder is in good condition.

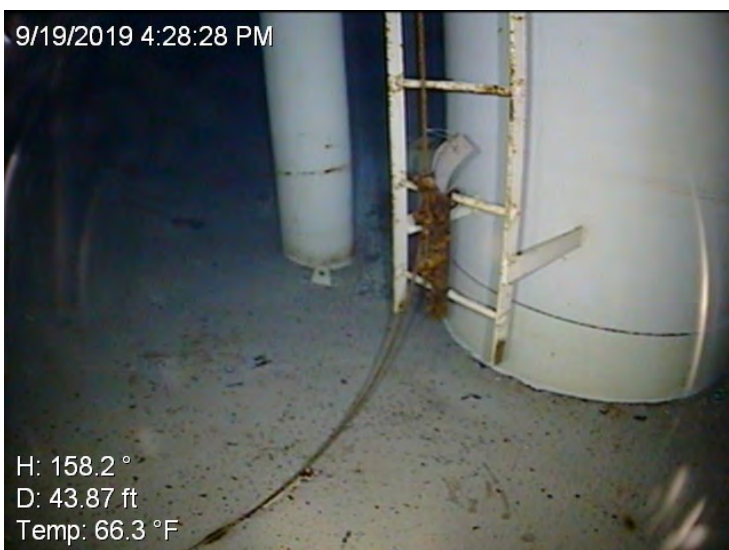
75) There is some corrosion on the bottom fall prevention ladder bracket.

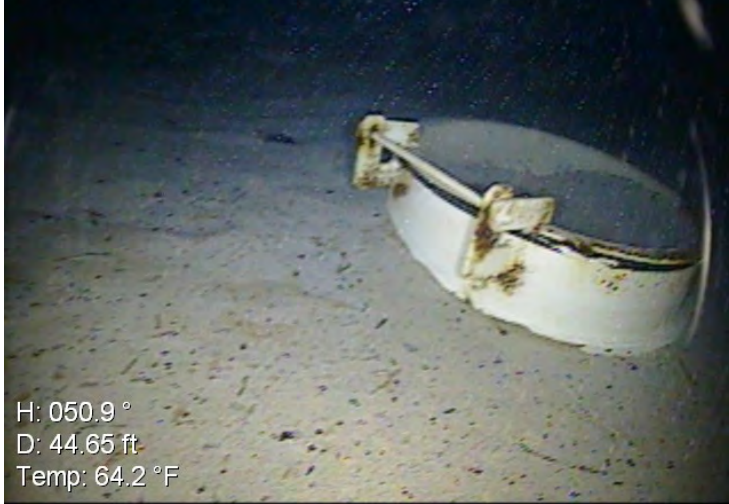
79) The coating on the wet interior manway is in poor condition.

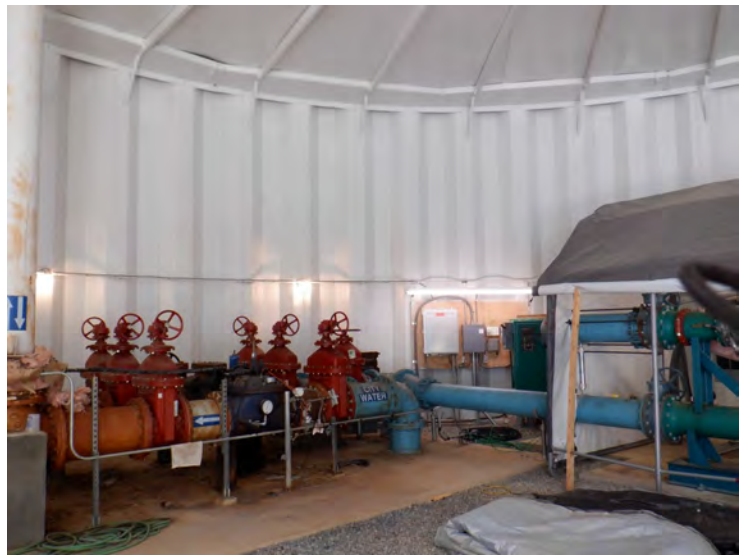
86) The coating on the piping above the floor in the column is in fair to poor condition.
