**City of Martinsburg**  
232 N Queen St, Martinsburg, WV 25401

# **Market House Building Evaluation**

July 30, 2021

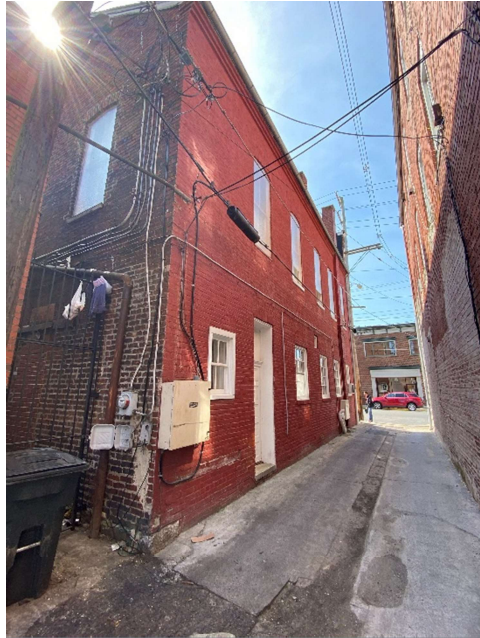
West end alley

Alleys provide additional ingress and egress opportunities on the ground floor at the west end of the building and a portion of the north side the building.

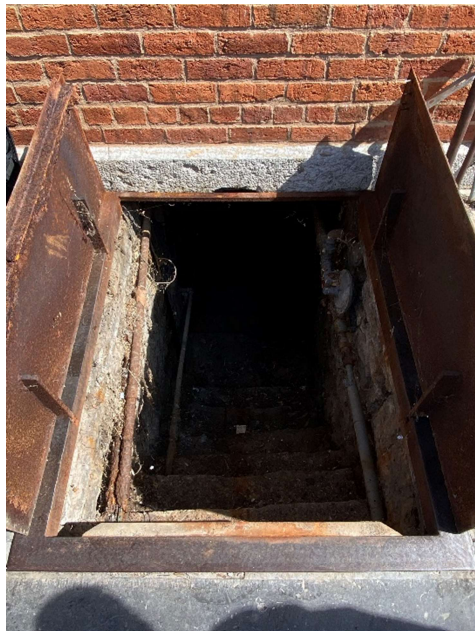
Partial Basement Sidewalk Access

The first floor consists of two major segregated spaces, the Queen Street tenant space and the Burke Street tenant space. Both are currently leased and observation of these spaces were not conducted. Under the Burke Street tenant space is a partial basement which can be accessed from a pair of sidewalk cellar doors. There are two primary second floor access stairs, one off of Queen Street and other off of Burke Street. A third second floor stair exists with a direct access to the West End Office Suite. The floor-to-floor height from the first floor to the second floor is approximately 12'-0".

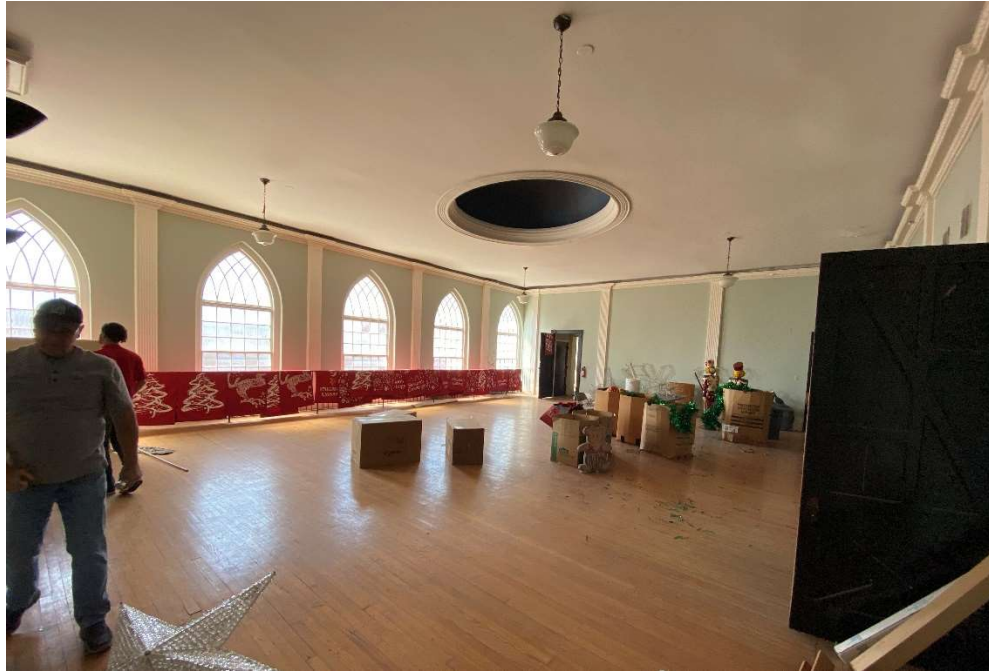
The wood flooring throughout the building is assumed to be the original flooring base on its size and wear. Much of it is exposed and in various stages of serviceable condition. The flooring in the South Side Ballroom has been maintained and is in very good condition. On the other hand, the East End Ballroom has not been maintained and has several locations where water damage has buckled the flooring. The West End Office Suite flooring is covered with carpeting but is assumed to have a similar wood base flooring.

South Side Ballroom shown window facing Burke Street

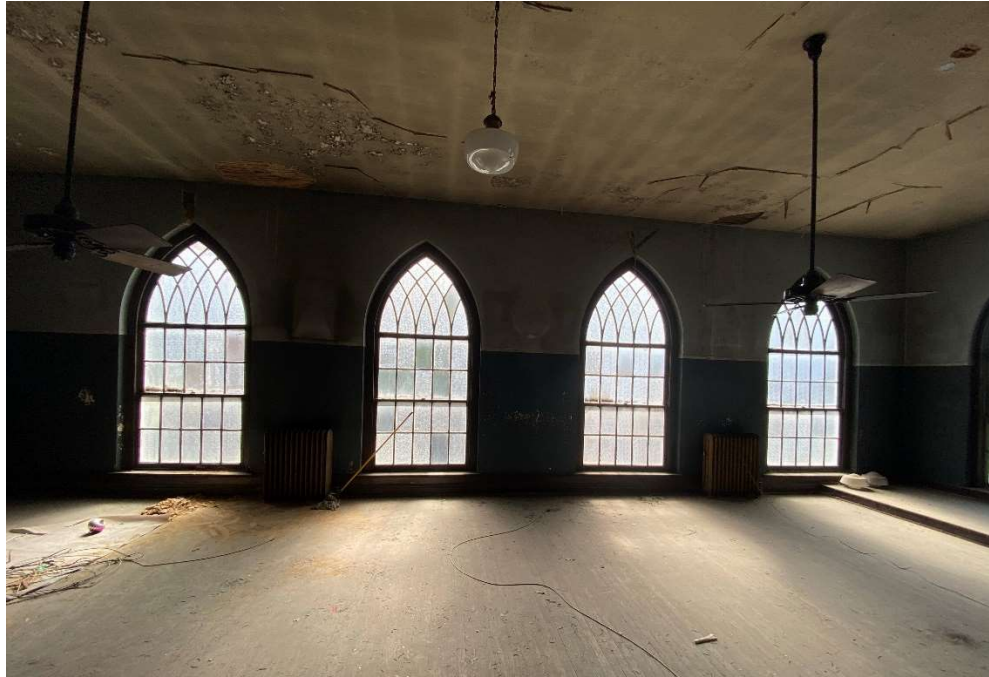
Within the buildings recent history, the roof was in need of repair which subsequently caused damage to the interior, primarily on the east end of the second floor. Without access to the attic space, it is unknown if any significant damage to the roof structure resulted. With limited visibility through a ceiling hatchway, it did not appear that such damage occurred. There is also no noticeable sign from the exterior that damage had occurred. The roof covering, consisting of asphalt singles and rubber membrane roofing, appeared to have been replaced recently which rectified any leaking that occurred in the past. There was no discernable means of determining if insulation was added above the roof framing and decking. However, it is clear that no insulation exists under the roof decking or between the rafters above the East End Ballroom.

East End Ballroom window wall facing Queen Street

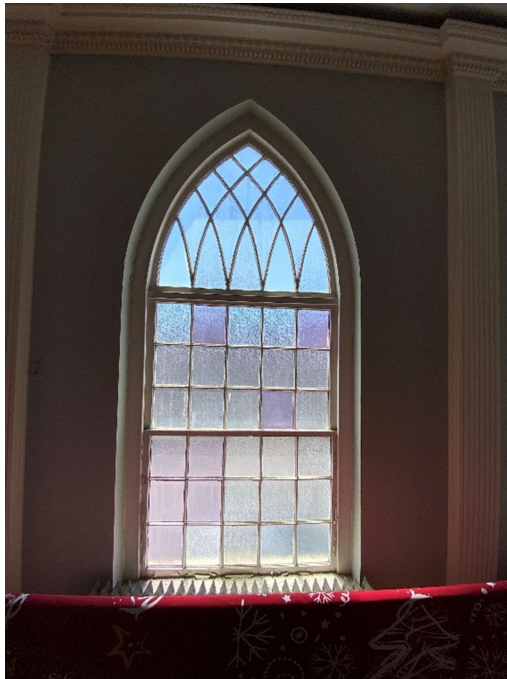
Pointed Arch Window

Windows at the second floor and the west end addition all appear to be original painted wood frame, single pane glazed, divided light windows. The second-floor elevations feature large gothic style pointed arch windows located in each of the ballrooms. These windows are approximately 5'-0" wide and approximately 11'-0" to the top of the pointed arch. At some point throughout its life, individual panes of glass have been replaced given the patchwork look and color variations of many panes of glass particularly on the Queen Street elevation. Most the windows within reach of the floor were constructed with operable sashes. Many

Maintenance work has been conducted to address cold air leaking in through gaps and broken panes but the windows remain extremely inefficient by energy efficient code standards. A single pane of glass has an R-value of approximately 1. New windows with insulated glazing and solar coatings are recommended and maybe an option for smaller windows such as those at the west end office suite. But given the building's historical distinction, matching the appearance of the larger feature window could be cost prohibited. Adding a second pane to the feature windows, is an option that would significantly improve its insulation value simply by creating a dead air space and minimizing infiltration.

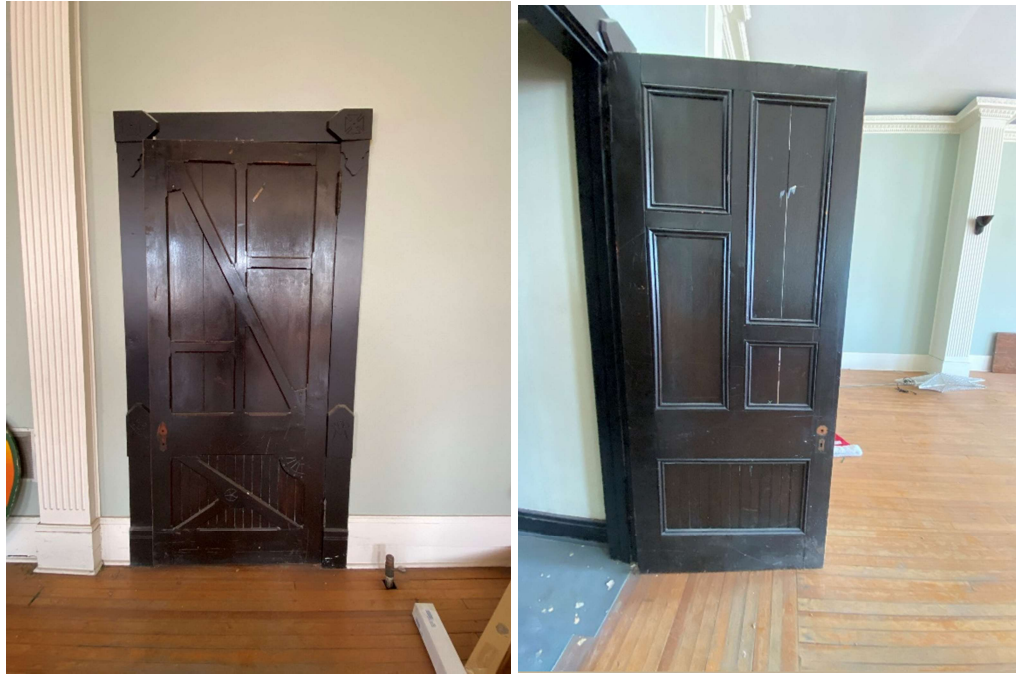
The doors are a mix of original and replacement wood doors, some of the original exterior access doors still maintain the transoms above. Several of the doors feature symbolic icons for the occupant use groups. Much of the operating hardware for interior doors has been changed and where appropriate at the time the doors were replaced. For any significant renovation particularly in the ballrooms and adjacent corridor, the doors should all be replaced to include accessible hardware.

South Side Ballroom Doors

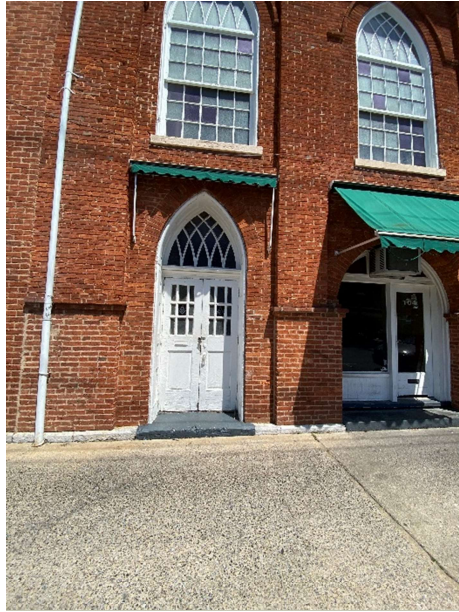
Accessibility to the second floor cannot be achieved without some type of accessible vertical circulation, preferably an elevator. This is where collaboration among all parties comes into play. Elevator cab size and fire separations are among the topics to be addressed within the context of the maintaining the historical fabric.

Burke Street Stair Entrance

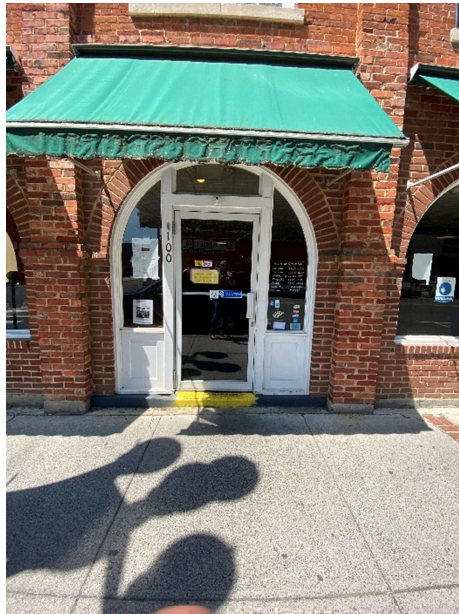
The Queen Street tenant space entry door width is suitable for accessibility but the Burke Street tenant space entry has a masonry opening at 3'-0" which is less than the required width when including the current door and frame. This is a situation where the city will need to determine if the historical fabric must be maintained. Otherwise, creative detailing of a door replacement maybe able to accommodate the full width of the opening.

Queen Street Tenant Entrance
