# **Dixon Engineering, Inc.**

Preliminary Maintenance Inspection  
1,500,000 Gallon Hydropillar  
(Boyd Orchard)

Martinsburg, West Virginia

Inspection Performed: September 19, 2019  
Reviewed by Joseph T. Hoban, P.E.: February 24, 2020

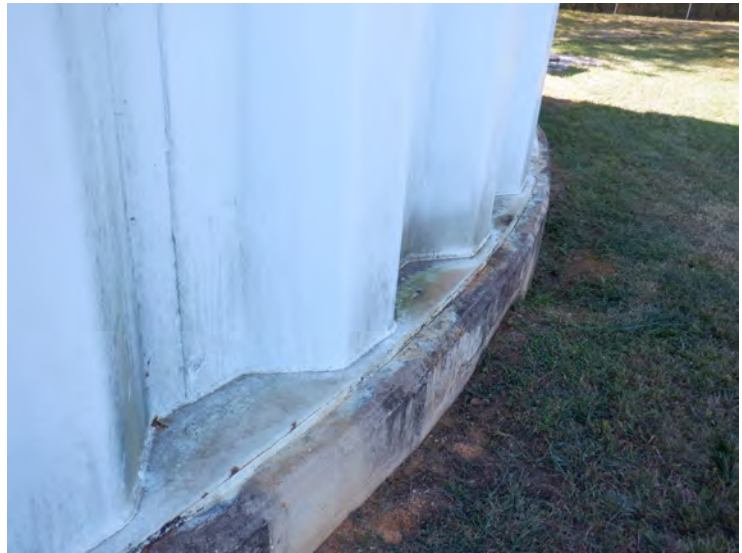
3) The electrical conduit penetrations in the column are not fully sealed.

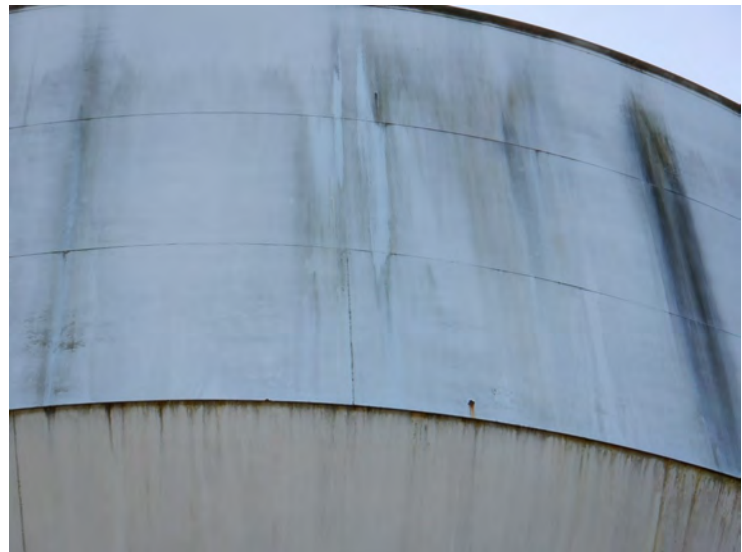
14) The sidewall coating is in fair condition.

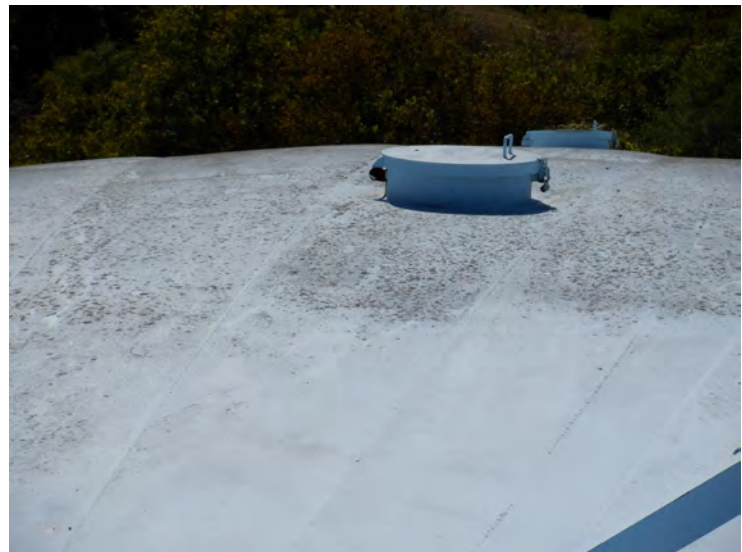
20) Two additional roof manways were not safely accessible.

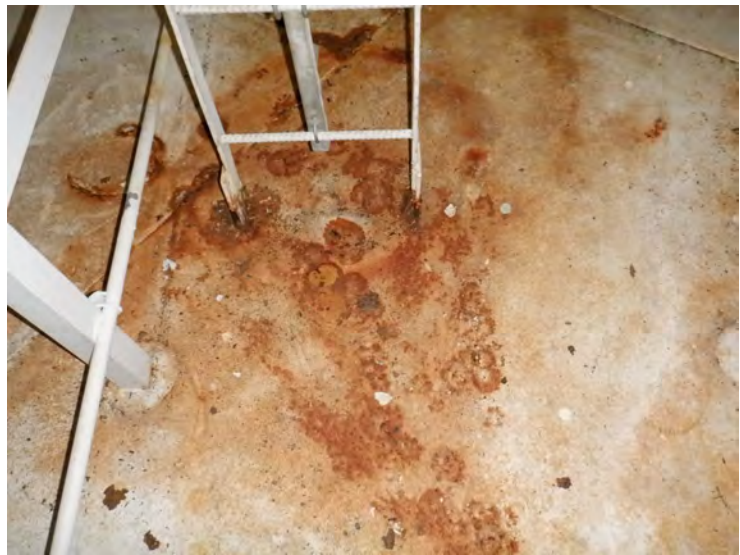
38) Same.

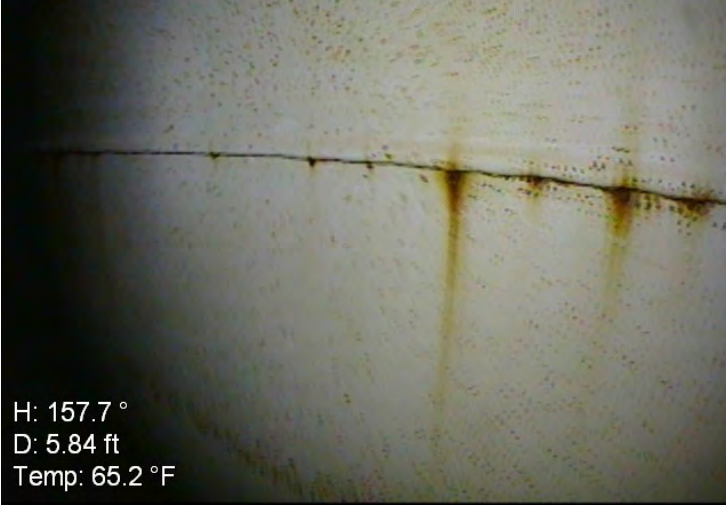
57) Spot coating failure to the substrate on the sidewall.

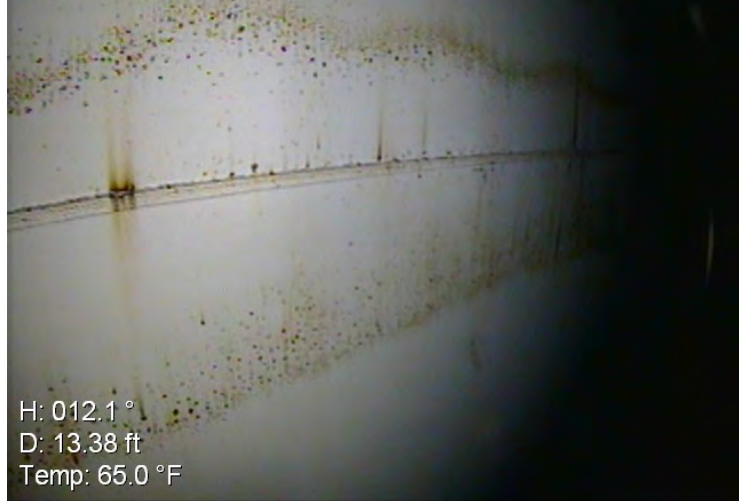
58) Spot coating failures to the substrate on a wet interior sidewall weld seam.

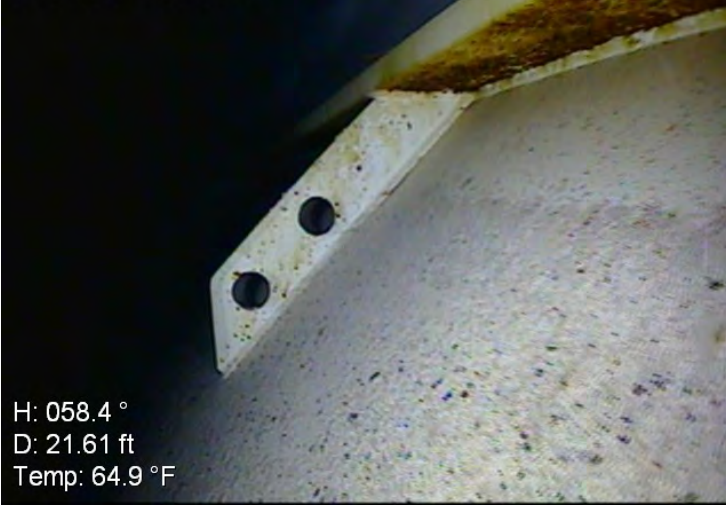
63) The stiffener at the transition is in good condition.

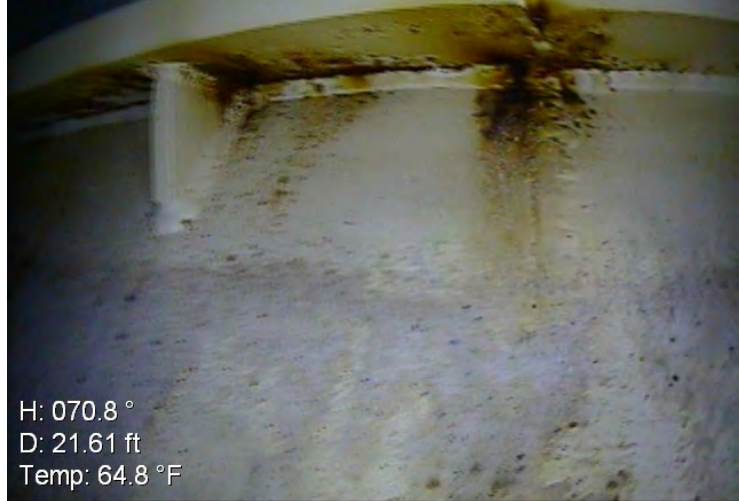
64) There are numerous spot coating failures to the substrate on the underside of the stiffener.

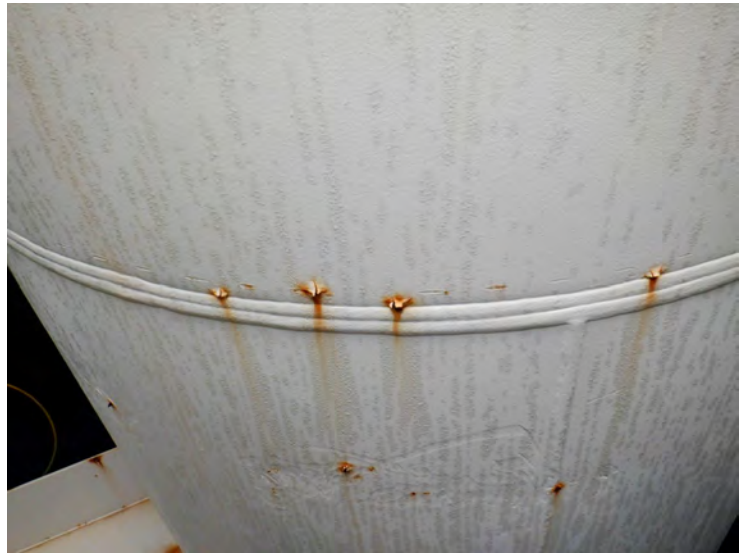
67) Spot coating failures to the substrate at the top of the access tube above high-water line.

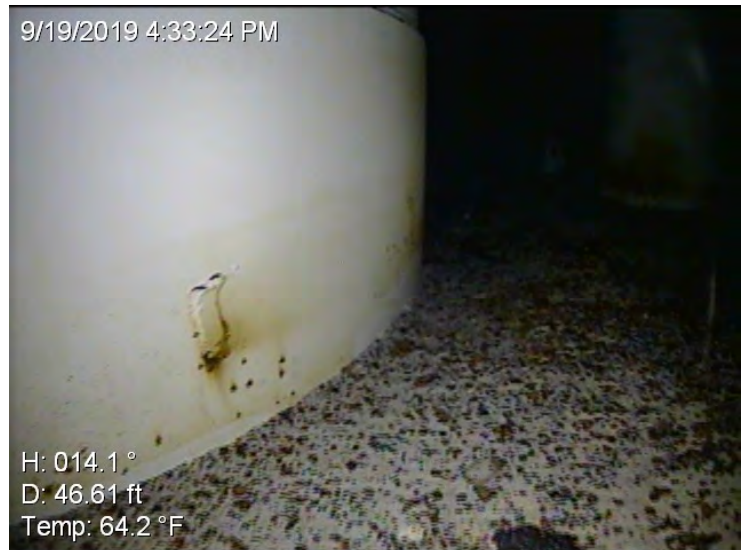
77) Spot coating failures on the fill pipe.

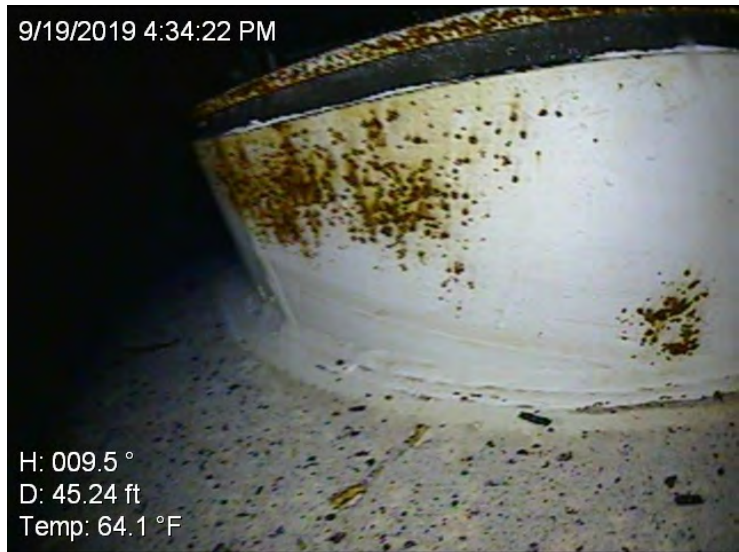
79) The coating on the wet interior manway is in poor condition.

80) Same.

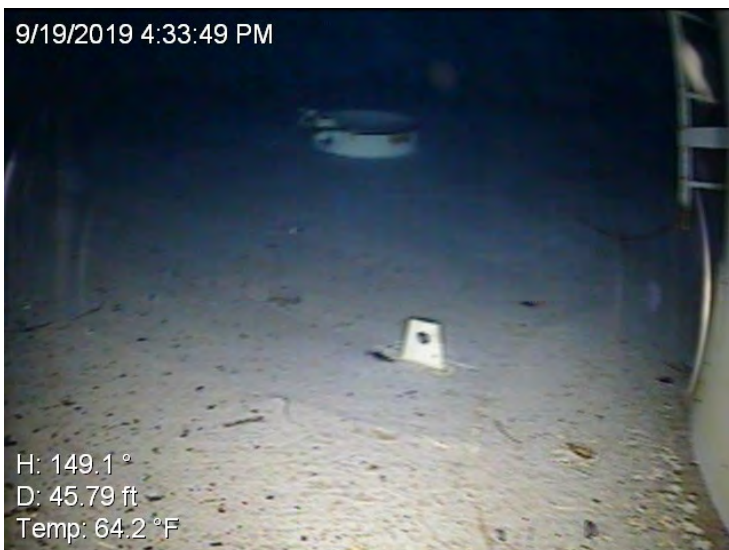
81) The sediment continues up the contour of the bowl.

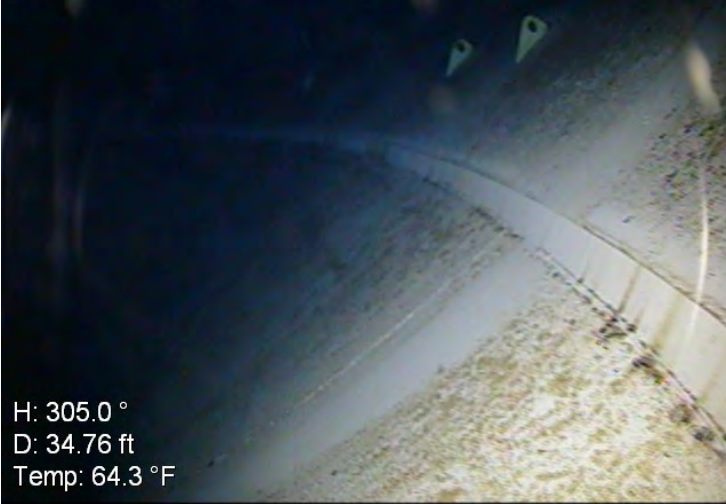
82) There are pinhole coating failures on the bowl weld seams.

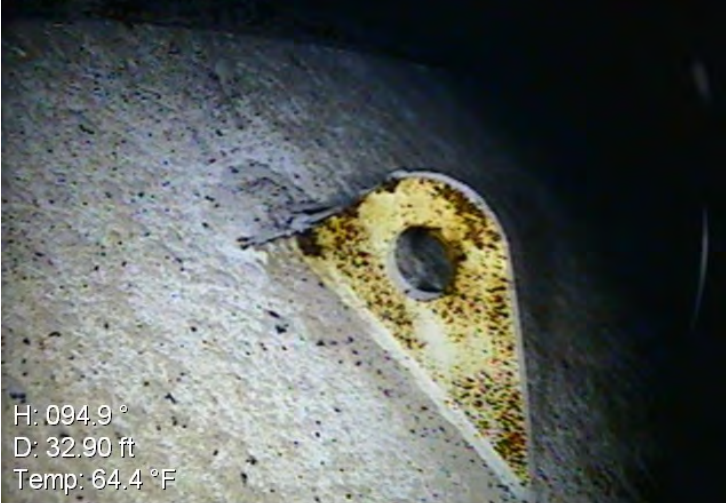
84) There is rust bleedthrough on the bowl erection lugs.

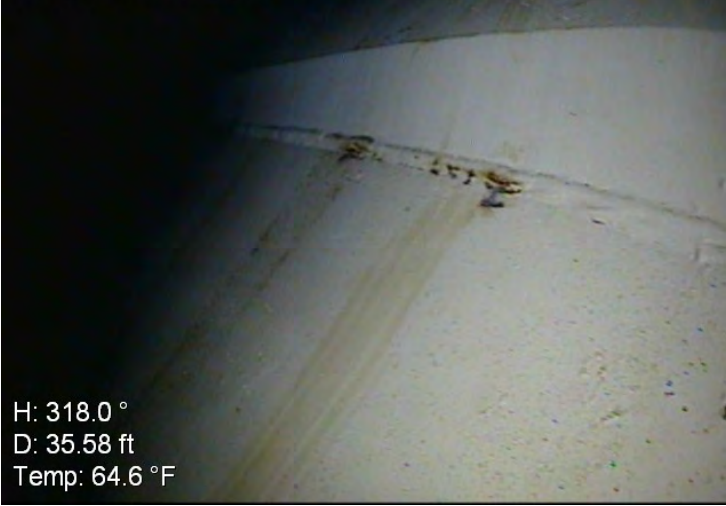
85) Spot coating failures an the upper bowl weld seam

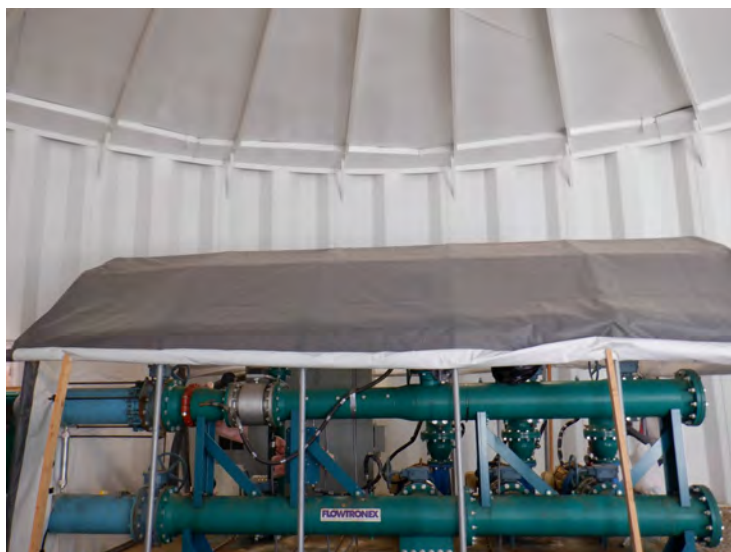
86) The coating on the piping above the floor in the column is in fair to poor condition.

87) Same.
